Spokane Reach PCB Canine Surveys 2021

Julianne Ubigau & Jasper
FieldLab Detection Services
September 2021

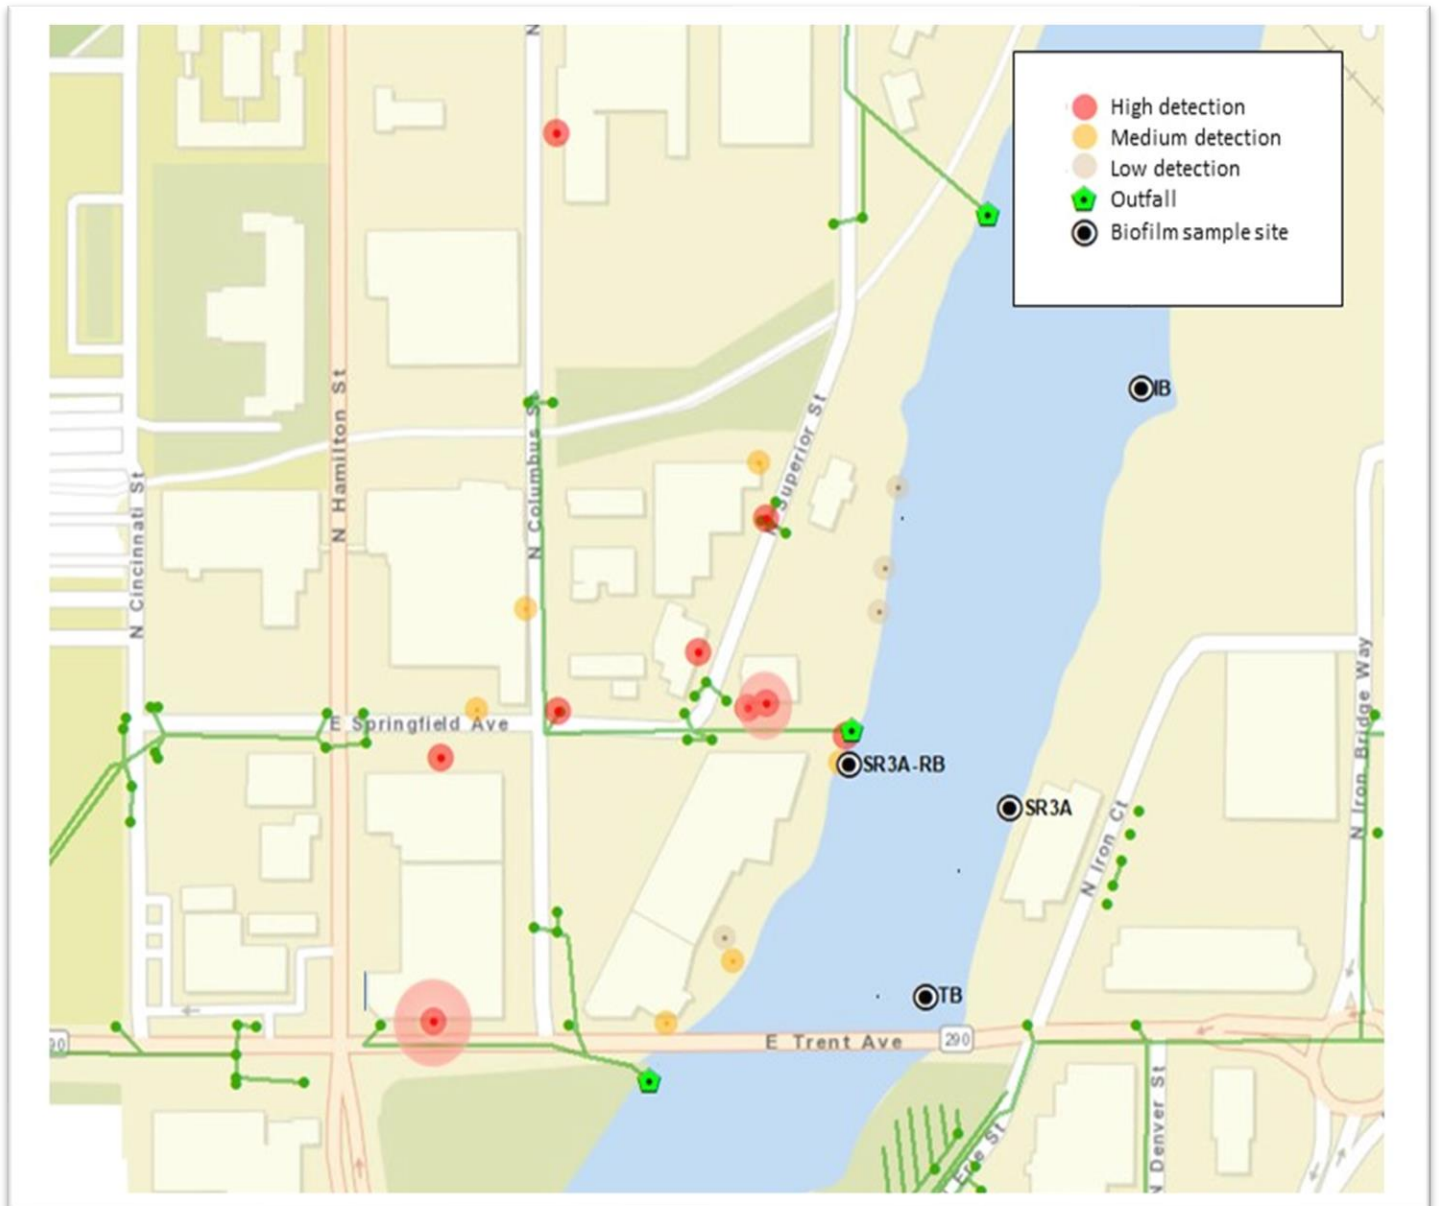
The most significant finding was an active outfall, less than 10 meters upriver from the SR3A-RB PCB hotspot (Figure 6). This outfall discharges stormwater from the area where PCB-contaminated buildings were detected.

Figure 6. Map showing canine detections, outfalls and biofilm sample locations.

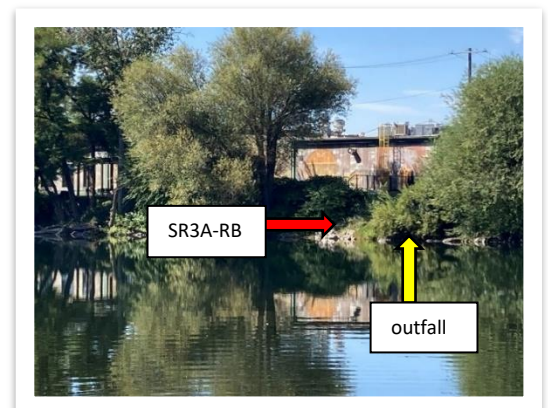
Canine detections were made along the bank and in water where the Springfield stormwater basin drains into the river (Figure 8). This stormwater line was installed in 1971 and the outfall is a bright green corrugated steel pipe that was submerged at time of surveys. There is heavy brush on the bank above the outfall, so Jasper did not work into the odor until getting down to the shoreline. Once there, he had high interest in the air between several large rocks and eventually pawed at the water near the submerged outfall. A video of our revisit to this site can be viewed in [PCB Canine Project](#) folder.

Figure 8. Springfield outfall and SR3A-RB hotspot.

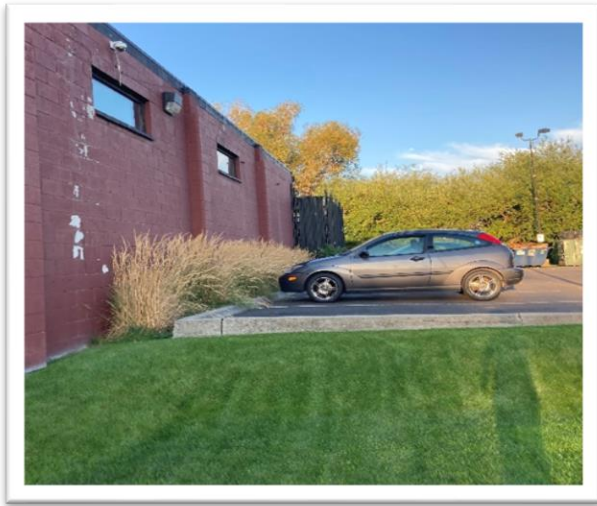
Jasper detected a strong PCB odor on south wall and west side of the building that is painted red. This building had layers of old paint that was peeling in some areas (Figure 9). The PCB odor was strong enough to be detected by the handler. Jasper also detected the target odor in a drainage area at the southwest corner of the building (Figure 10). Sampling soil within or near this drainage area is recommended.

Figure 9. Building 704 south wall with PCB paint

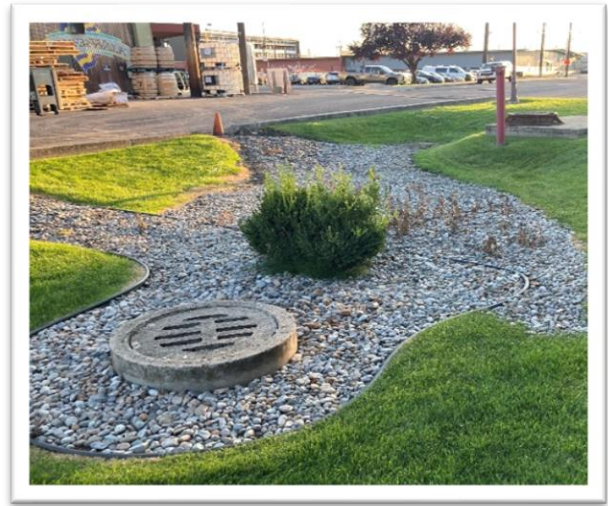
Figure 10. Drainage area at SW corner of 704 building.

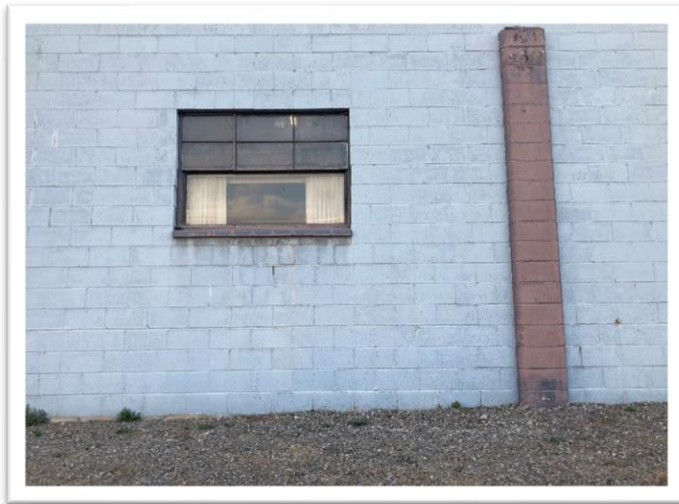
Detections were made along east-facing wall of 711 building (Figure 11). This building was a cinderblock structure with multiple layers of old paint. Stronger detections were made under windows and at pillars (Figure 12). The team did not have access to the property so only the east side of building along N Superior Street was surveyed. Sampling of soil/gravel at base of building is recommended.

Figure 11. East face of 711 building.

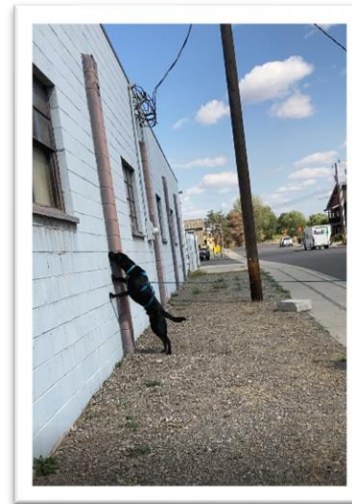
Figure 12. Detections at red paint

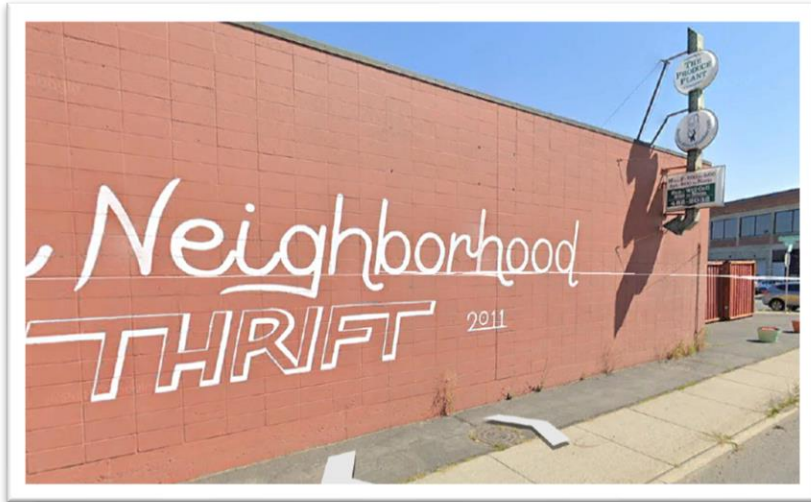
Jasper detected strong PCB odor from painted cinderblock walls on east and south facing walls (Figures 13 and 14). Jasper indicated interest in entire building but concentrations along Trent Ave were strong enough to be smelled by the handler. Jasper also had a strong detection in the private drain in the north parking lot. Historical data shows that there was a company (United Body & Fender) that specialized in painting boats and autos throughout the 60's and 70's. The company address was 625 N Hamilton which sits at the NW corner of this building. Residual PCB contaminants could be in the property's private drainage wells. Determining if and when these catch basins were cleaned by the property owner is recommended. Testing this catch basin is highly recommended.

Figure 13. South side of 600/900 building

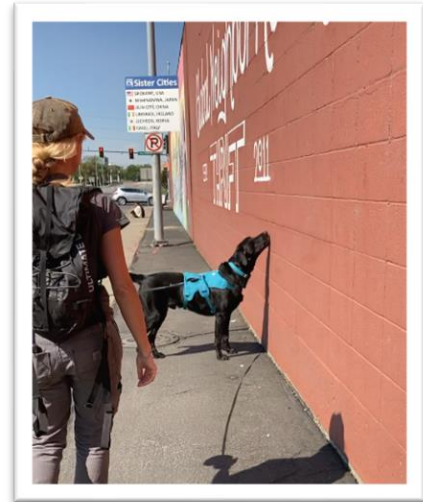
Figure 14. Jasper detecting PCB paint

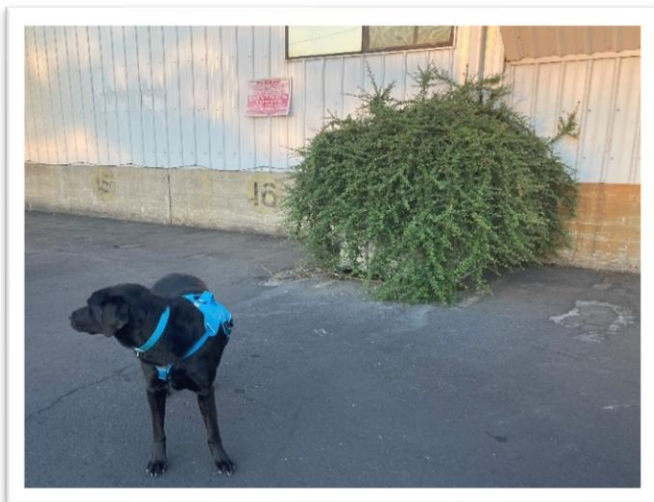
Canine detections were made at various locations around the perimeter of the 700 N Hamilton building complex. There was special interest in filtration planter boxes on west side of building, along N Hamilton Street (Figure 15). [Gratix](#) filtration boxes remove zinc from galvanized roofs and downspouts. These filtration boxes could also catch PCB pollution from old [Galbestos](#) metal roofing and siding which was made using zinc and PCB additives in the late 40's through late 70's. Aerial data from Google Earth shows that the roof was replaced or resealed in 2014.

Figure 15. Gratix filtration container at 700 building

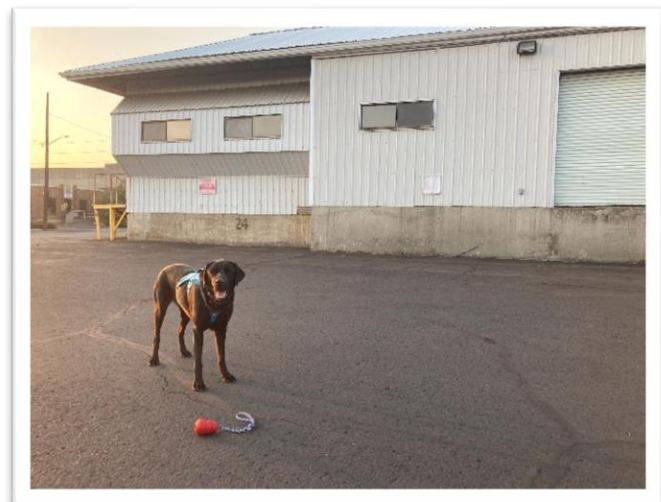
Figure 16. Jasper after detection at fence line of 700 building

High confidence detections were not made at this site because access was limited. The PCB source could be from inside building, from the roof, or siding. Sanborn maps of the area shows that Trues Oil Company operated at this location in the 1950's. It is possible that residual oil contaminants have saturated the ground in and around this facility. Sampling the soil and debris at fence line (N Springfield) and sampling soil along west side of building (N Columbus St) and at southern fence line is recommended.

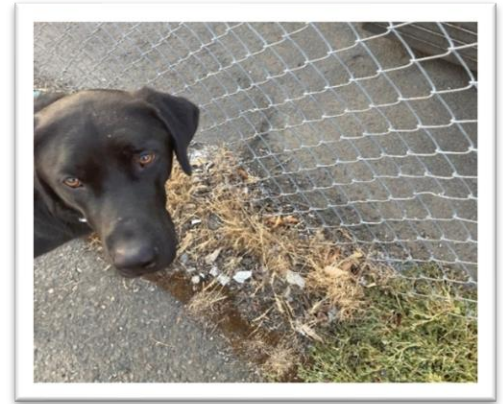
Jasper also detected possible target odors along fence line at southern border of property (Figure 17). Special interest was also displayed along the east side of building complex, along N Columbus Street.

Figure 17. Debris at south fence line of 700 building.

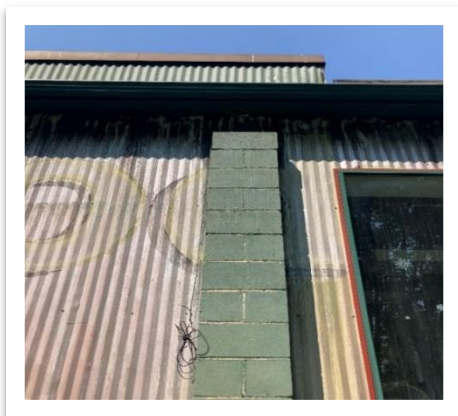
Jasper had a low to moderate response to green cinderblock columns on the Riverwalk building and had a moderate response to similar cinderblock debris found on bank near the Riverwalk building (Figures 18 and 19).

Figure 18. Green column at Riverwalk building

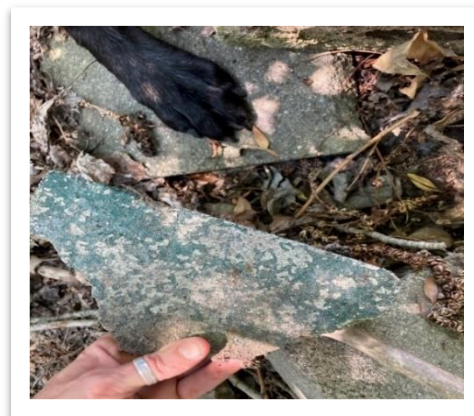
Figure 19. Green cinderblock debris on bank
