Report:
**PCB Characterization of Spokane Regional
Vactor Waste Decant Facilities**

Prepared for the Spokane River Regional Toxics Taskforce

September, 2015

City of Spokane RPWRF Laboratory
4401 North A. L. White Parkway
Spokane, WA 99205

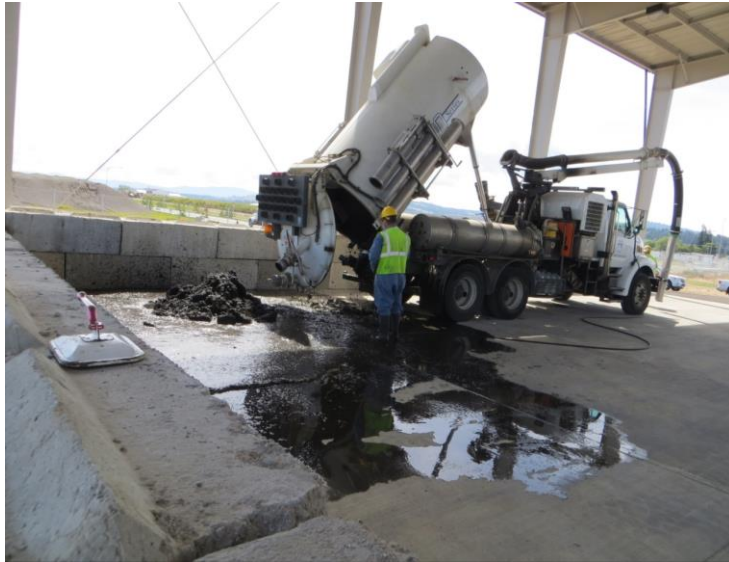
The City of Spokane Decant Facility is located at 2813 E. Ferry Ave. on what was formerly the Playfair site. The facility consists of an approximately 20,000 square-ft covered concrete slab which drains into an evaporation pond. The evaporation pond was designed such that overflows would not occur. Stormwater sediment is taken to landfill after it has sufficiently dried on the pad. The landfill the City currently uses is the North Side landfill, but plans are underway to transition to the Graham Rd. landfill. It is anticipated that solids will accumulate in the pond over time and will have to be removed periodically and taken to landfill as well.

Fig-1 City of Spokane Decant Facility – vacor unloading

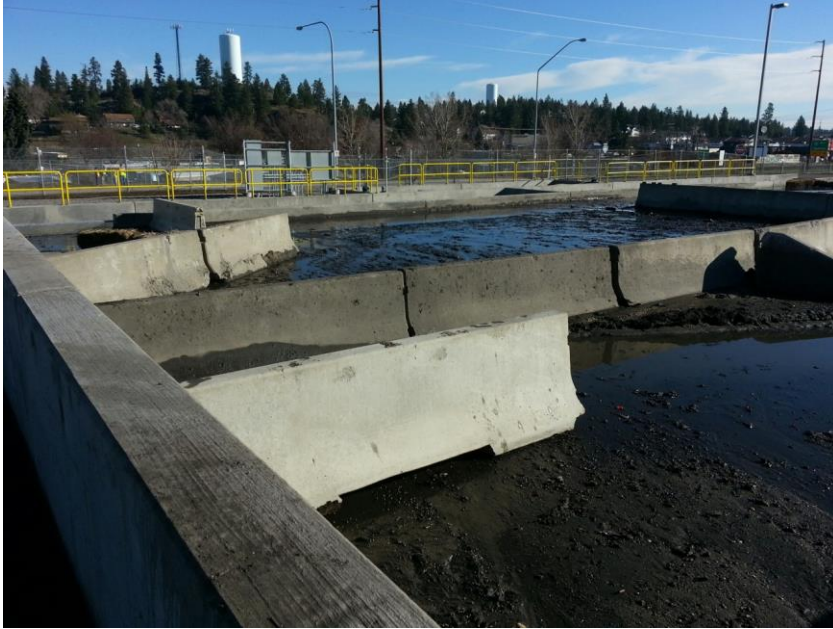
The joint City of Spokane Valley –WSDOT facility is located at E. 12102 Montgomery Dr., adjacent to I-90, just west of the Pines Exit. The facility consists of an approximately 6,400 square-ft slab which allows decanted material to drain into an adjacent settling pool. Water from the settling pool is then directed to an oil-water separator, followed by a sand filter bed, and finally to a bio-infiltration pond. Stormwater exceeding the capacity of the bio-infiltration pond is directed to a drywell. There are plans to cover this facility in the future as well as potentially discharge decant-water to the sewer leading to the Spokane County Reclamation Facility.

Fig-2 City of Spokane Valley/WSDOT facility

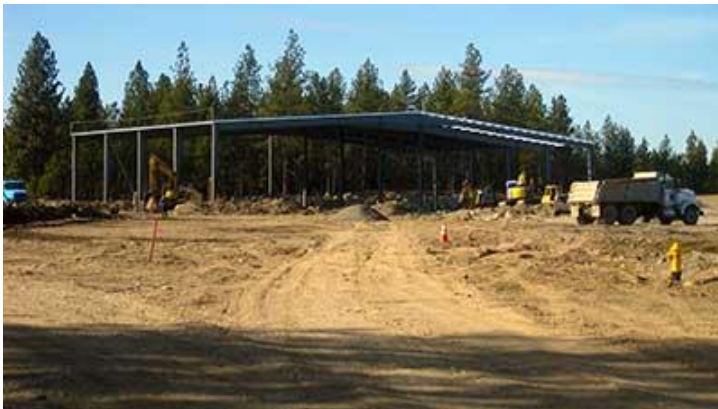
Construction is currently underway for the Spokane County Facility at 12807 N. Mayfair in North Spokane and is anticipated to be completed by mid-2015. The capacity of the facility will be similar to the Playfair location, with a 100-ft-by-200-ft covered concrete slab. Decanted liquid will be treated with an oil-water separator followed by a bio-swale and dry well. Testing of this facility was not included in this study.

Fig-3 Spokane County Decant Facility – under construction

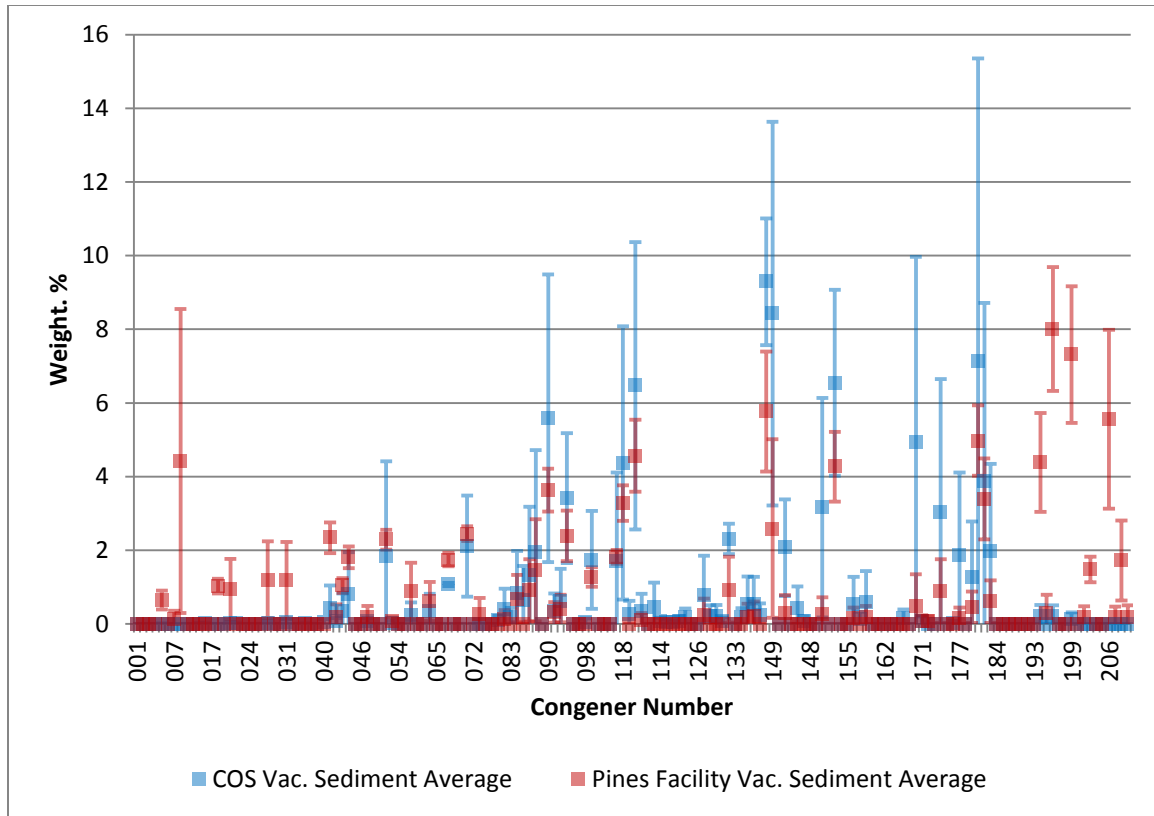
Figure 4 shows a comparison between individual congeners in the sediment at each of the two facilities monitored. For comparison purposes, each congener is represented as a ratio of the individual concentration to the total PCB concentration for a given sample. The error bars represent ± 1 standard deviation. As can be seen in the graph, the City of Spokane sediment appears to be more heavily concentrated in the mid-weight congeners whereas the Pines Facility samples appears to contain several lower and higher weight congeners that were not detected in the COS samples. PCB 11 was one of the lower weight congeners that was detected in the Pines Facility samples that did not show up in the COS samples. PCB 11 is often associated with PCBs generated inadvertently through the production of chemicals such as yellow dye and is generally not found in arochlor formulations of PCBs.

Fig-4 Congener Comparison between Pines Facility and COS Sediment Samples

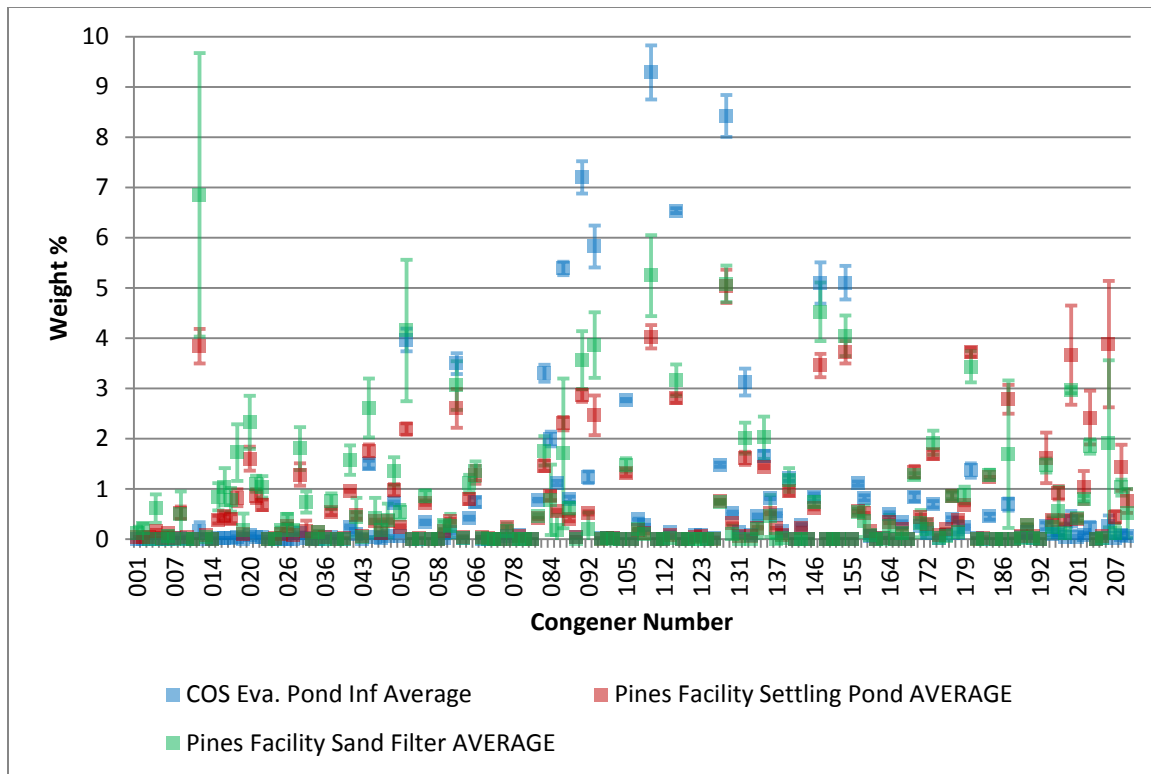
Figure 5 is a similar comparison between the COS and Pines Facility liquid samples. Congener distributions appear to generally match with the sediment samples for each of the two sampling locations. It should be noted that the coeluting congeners differ between the method used for the sediment samples and the liquid samples and thus a direct comparison between the two datasets is made more difficult. The congener pattern of the Pines sand filter also correlates well with Pines Facility settling pond sampling, with perhaps a slight shift from some of the heavier weight congeners in the settling pond to more of the lighter weight congeners once the material passes through the sand filter.

Fig-5 Congener Comparison between Pines Facility and COS Liquid Samples

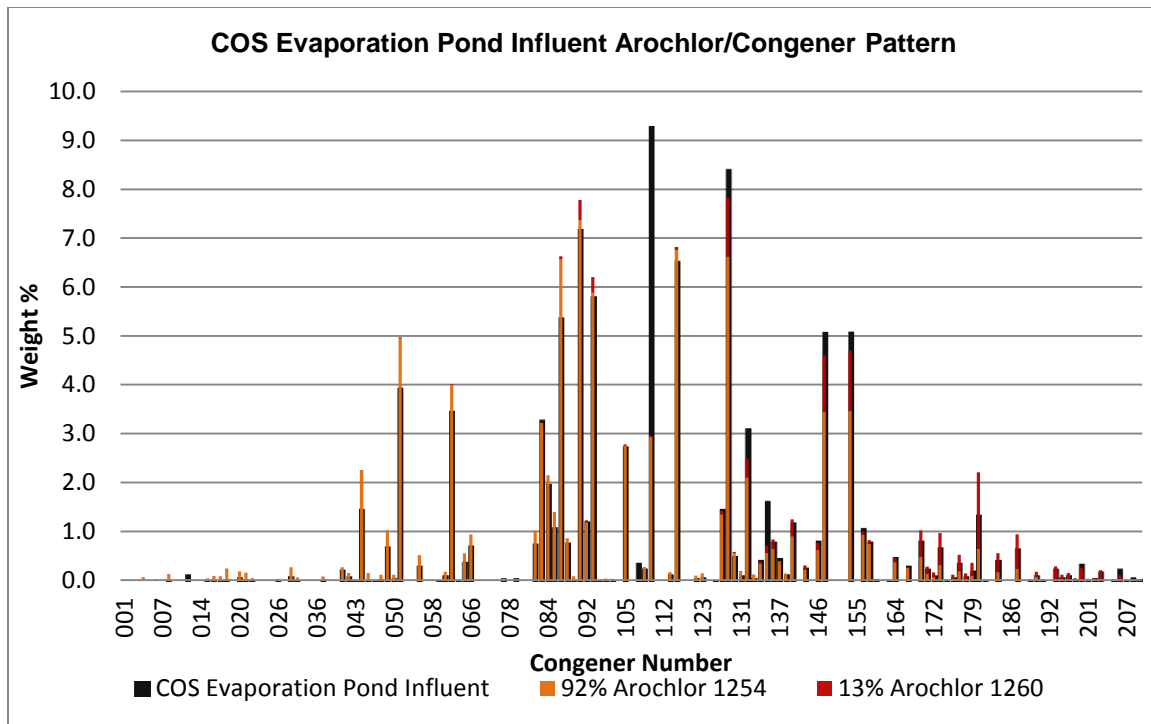
Figures 6 and 7 compare the COS Evaporation Pond Influent and the Pines Facility Settling Pond samples, respectively, to the best-fit combination of specific Arochlors. Arochlors were fit to the data by minimizing the sum of the square of residuals when comparing each congener in the sample to the corresponding weighted sum of the four most commonly found Arochlors (Arochlors 1242, 1248, 1254, and 1260). The COS sample appears to contain primarily Arochlor 1254 with a small amount of Arochlor 1260; the Pines Facility sample includes all four Arochlors with Arochlors 1254 and 1260 being more pronounced. As was noted before, PCB-11 was not part of any of the original Arochlor formulations but appears to be significant in the Pines Facility sample. Some of the higher weight congeners in the Pines Facility sample also appear to be higher than what would be expected from the congener distribution of native Arochlor mixtures. The coeluting PCBs 110 and 115 appear to be significantly higher in both the COS and Pines Facility samples than what would be expected from a combination of Arochlors.

Fig-6 COS Arochlor Composition

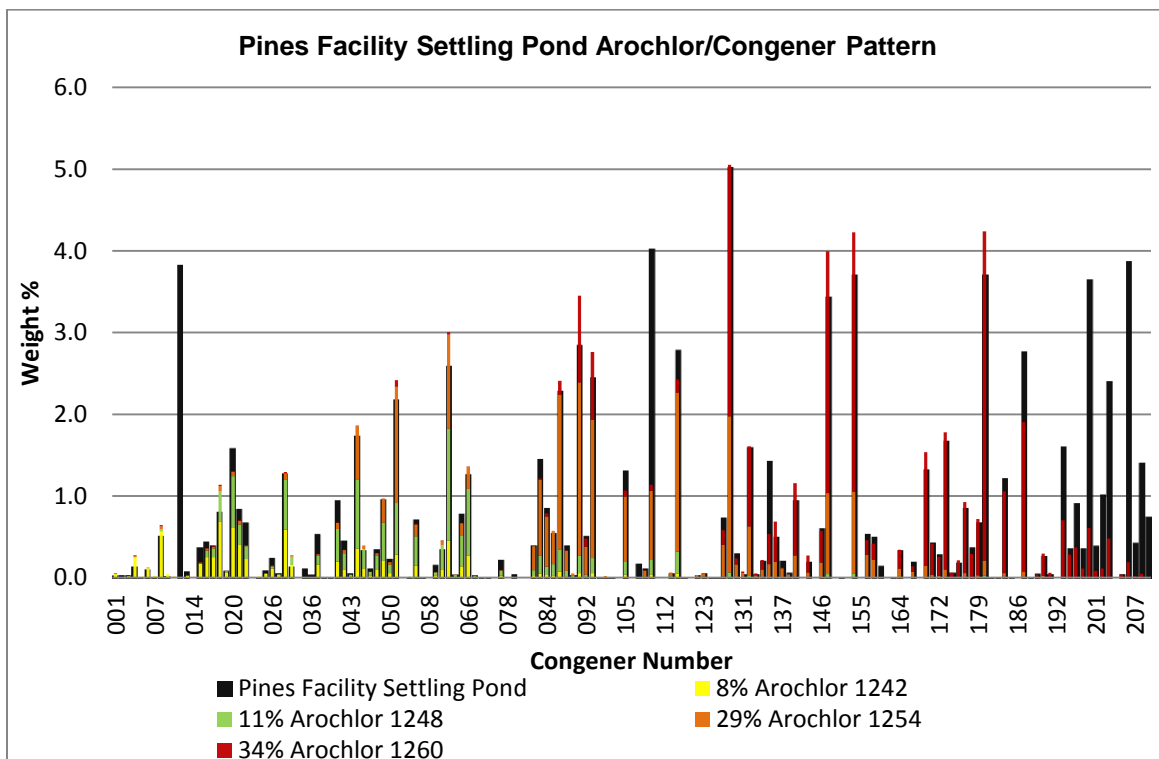
Fig-7 Pines Facility Arochlor Composition

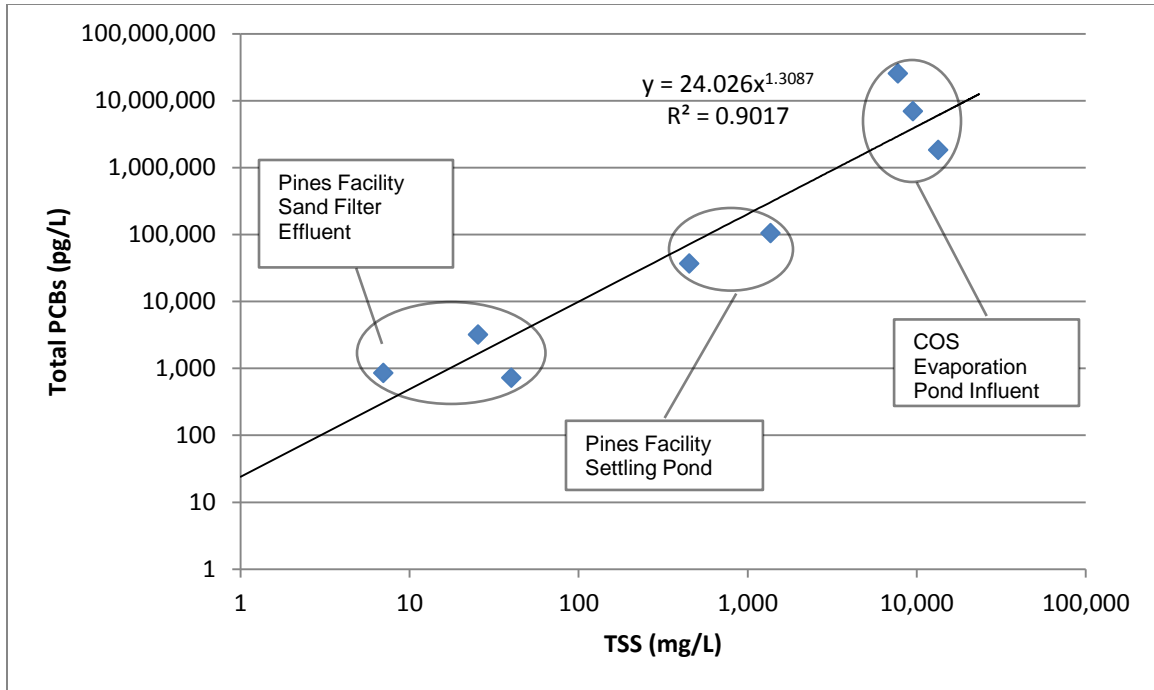
For the liquid samples tested, total PCB levels generally correlated well with total suspended solid concentrations (see: Fig-8). PCBs are predominately hydrophobic and typically adhere to the particulate material in a given waste stream so seeing this correlation would be expected. Similar correlations were found between total PCBs and the metals that were tested. This is likely more of a function of suspended solids content rather than a direct relationship between pollutants.

Fig-8 PCB/TSS Comparison. Note: Logarithmic-Scale
