# **Draft Fish Tissue and Artificial Bottom Fill Reports**

Task Force Meeting

June 23, 2021

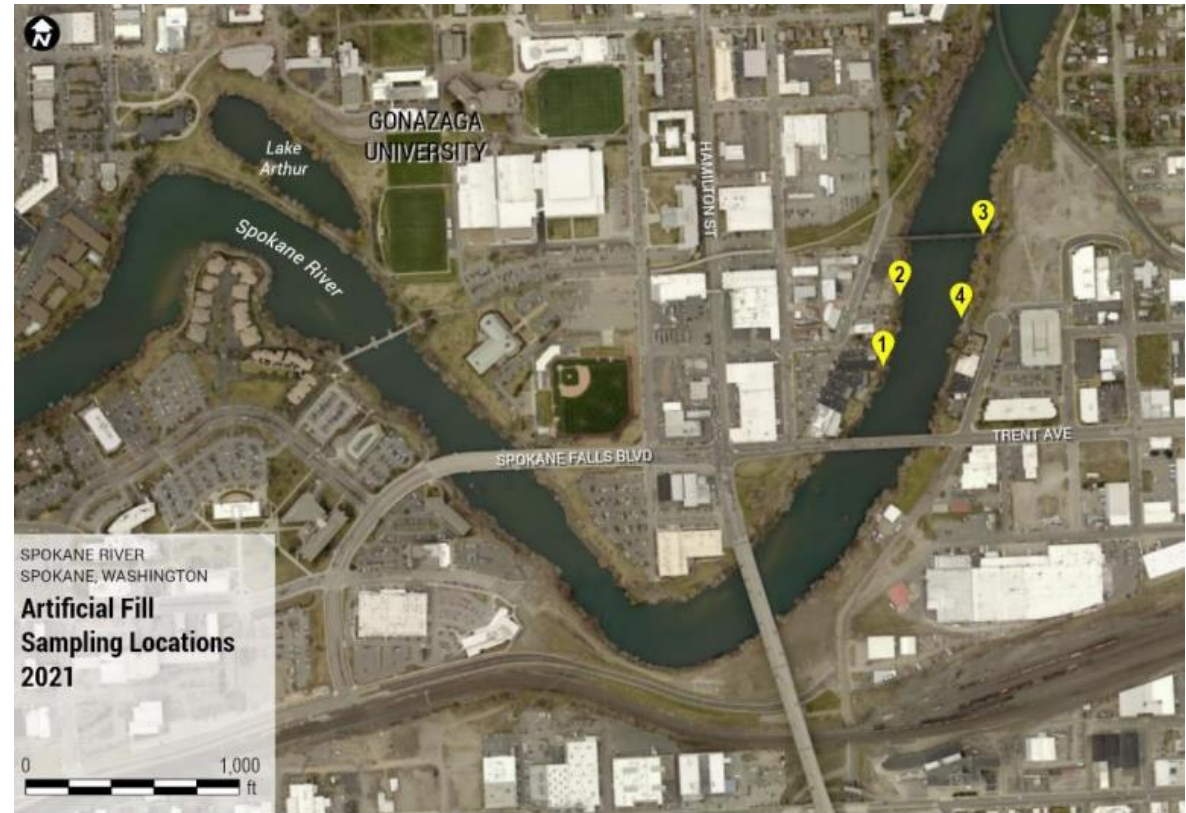
# Sampling Areas

- Samples collected from four areas in vicinity of the highest biofilm PCB concentrations

Area Number	Location Descriptor
1	Behind Northern Lights Brewing
2	Right bank halfway between Northern Lights Brewing and foot bridge
3	Left bank near foot bridge
4	Left bank across from Northern Lights Brewing
