Spokane River Regional Toxics Task Force Evaluation of PCBs in Spokane River Artificial Bottom Fill Material

Prepared for:
Spokane River Regional Toxics
Task Force

July 20, 2021
FINAL APPROVAL DRAFT

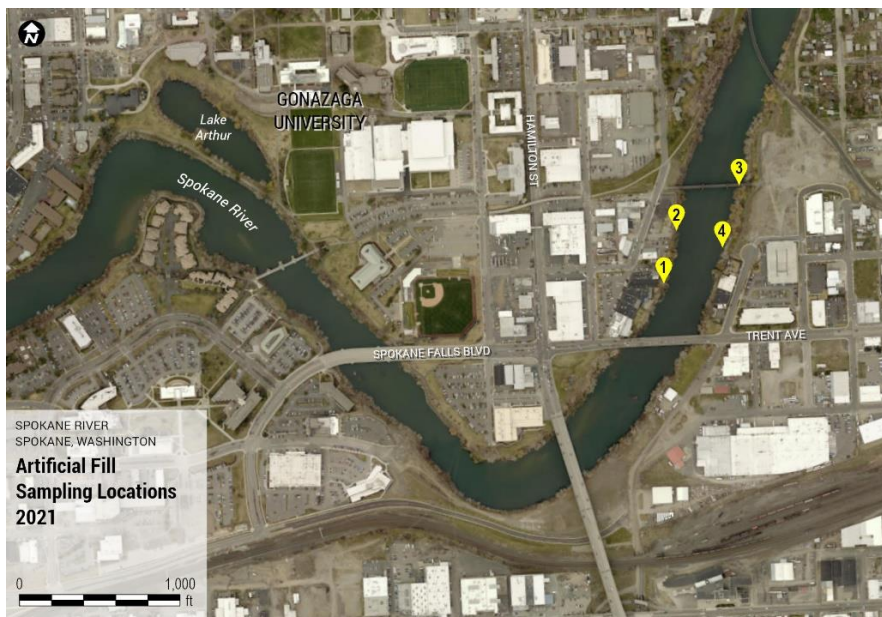
Figure 1. Map of Sampling Area Locations

Sampling locations consisted of four different areas within the Mission Reach, described in Table 1 and shown in Figure 1.

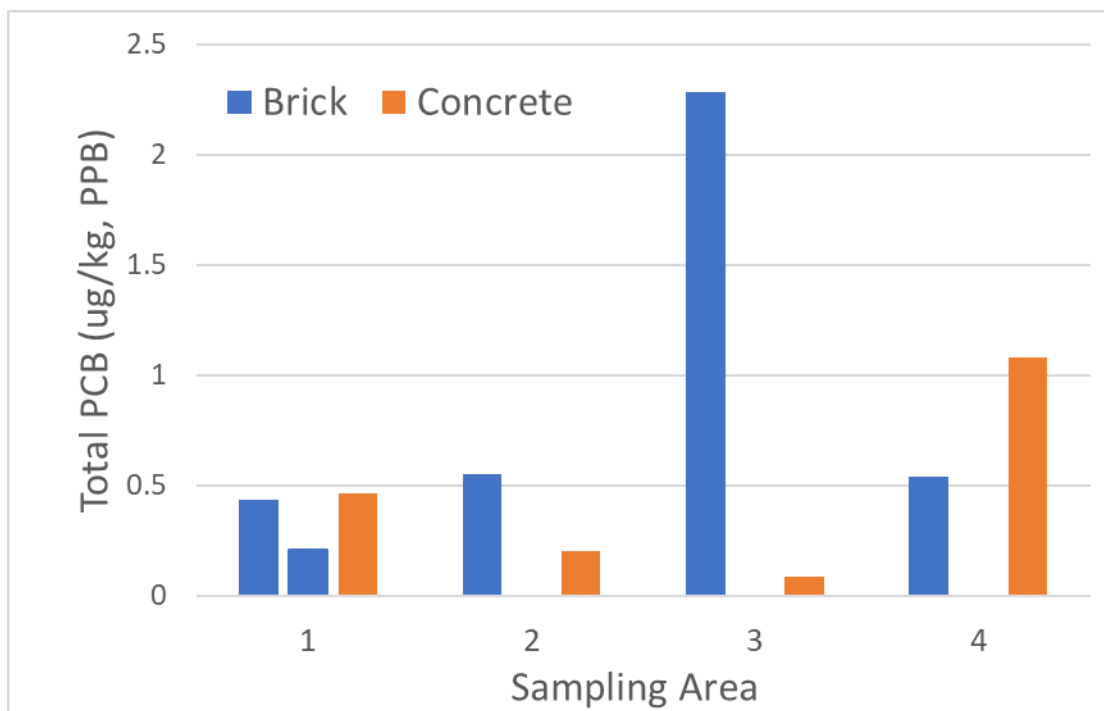
Figure 2. Spokane River Artificial Fill Total PCB Concentrations ($\mu\text{g}/\text{kg}$)

Total PCB concentrations for each area and substrate type are provided in Table 2 and plotted in bar chart format in Figure 2. In addition, the single sample of asphalt substrate had an observed total PCB concentration of 13.7 $\mu\text{g}/\text{kg}$.

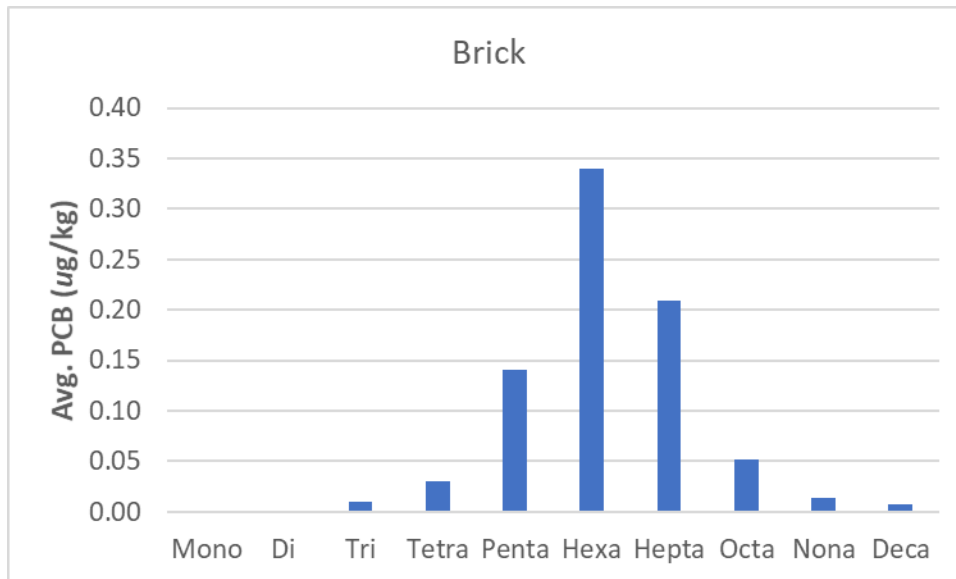
Figure 3. Average Blank-Corrected Homolog Concentrations for All Brick Samples.

Homolog distributions are provided in Figures 3 through 5, showing average concentration by homolog across all samples for each substrate type. These data are provided in tabular format for each individual sample in Appendix A. Concentrations in brick and asphalt are dominated by the hexa-chloro homolog, while concentrations in concrete are dominated by the penta-chloro homolog.
