Spokane River Regional Toxics Task Force Evaluation of PCBs in Spokane River Artificial Bottom Fill Material

Prepared for:
Spokane River Regional Toxics
Task Force

~~June-July 1620~~, 2021
FINAL APPROVAL DRAFT

LimnoTech

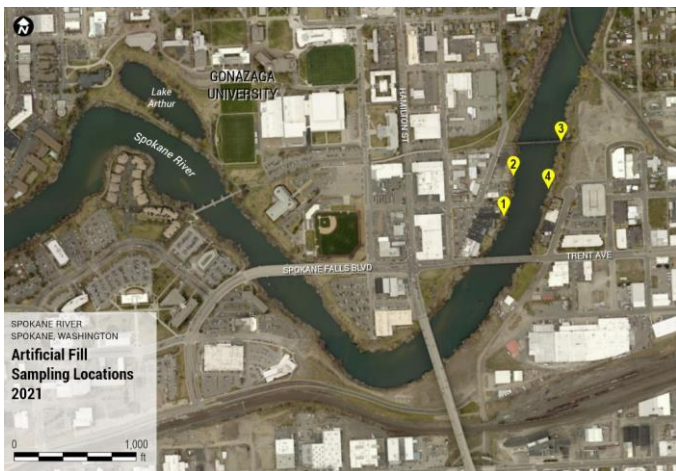
Figure 1. Map of Sampling Area Locations

Sampling locations consisted of four different areas within the Mission Reach, described in Table 1 and shown in Figure 1.

Area Number	Location Descriptor	Latitude	Longitude
1	Behind Northern Lights Brewing	47.66286° N	-117.39339° W
2	Right bank halfway between Northern Lights Brewing and foot bridge	47.66378° N	-117.39315° W
3	Left bank near foot bridge	47.66448° N	-117.39138° W
4	Left bank across from Northern Lights Brewing	47.66344° N	-117.39193° W

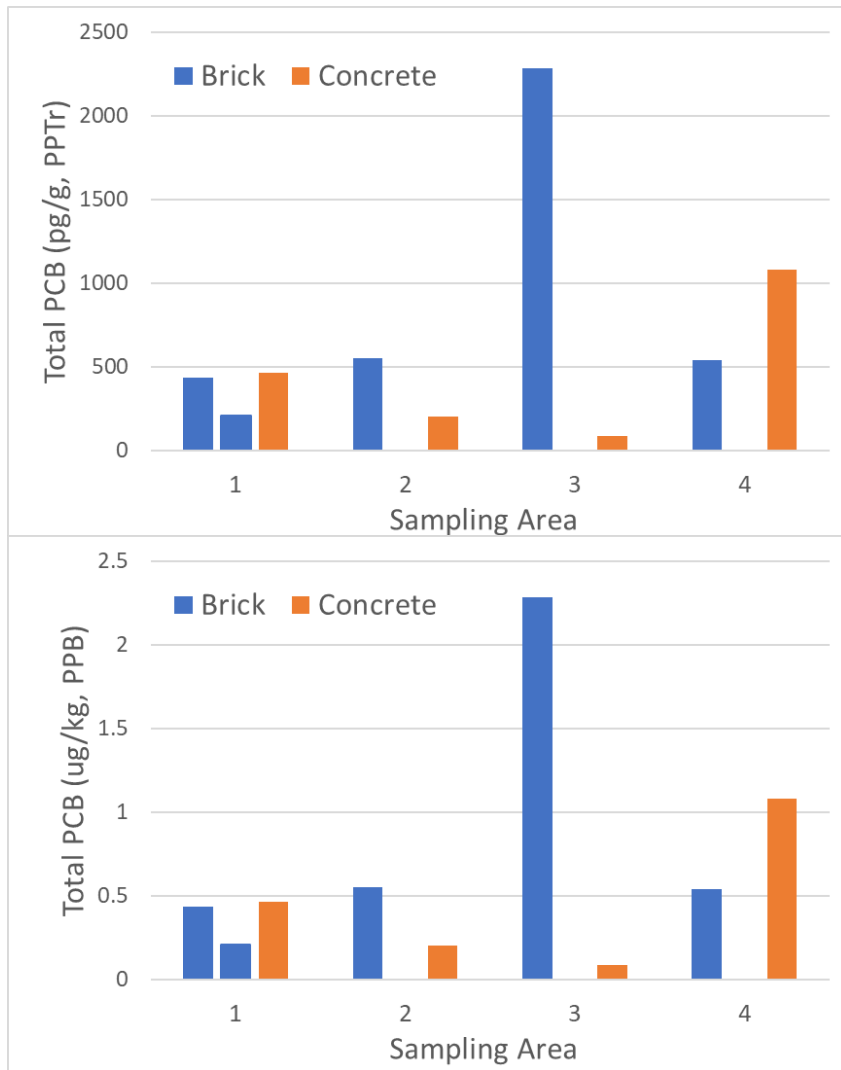
Figure 2. Spokane River Artificial Fill Total PCB Concentrations (pgug/kg)

Total PCB concentrations for each area and substrate type are provided in Table 2 and plotted in bar chart format in Figure 2. In addition, the single sample of asphalt substrate had an observed total PCB concentration of ~~13,700~~ pgug/kg.

Area	Substrate Type	
	Brick	Concrete
1	<u>0.438</u>	<u>0.465</u>
	<u>0.208</u>	
2	<u>0.553</u>	<u>0.204</u>
3	<u>2.283</u>	<u>0.087</u>
4	<u>0.541</u>	<u>1.084</u>

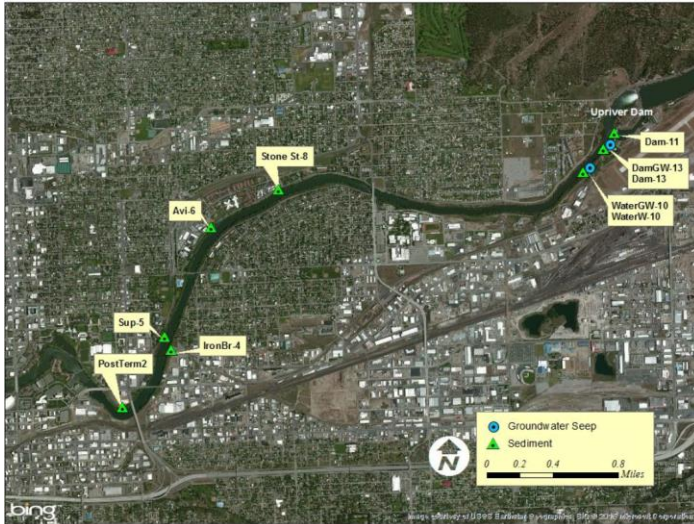
Figure 6. Ecology's Urban Waters Program 2013 Sediment Sampling Locations (from Era-Miller, 2015)

Ecology's Urban Waters Program sampled PCB content in Spokane River bottom sediments at eight locations in August 2013 (Figure 6). Seven of the stations were located upstream of the peak observed biofilm PCB concentrations, with the eighth location (named PostTerm2) located within the Mission Reach hot spot area.
