# Spokane River Regional Toxics Task Force Evaluation of PCBs in Spokane River Artificial Bottom Fill Material

Prepared for:  
Spokane River Regional Toxics  
Task Force

July 30, 2021

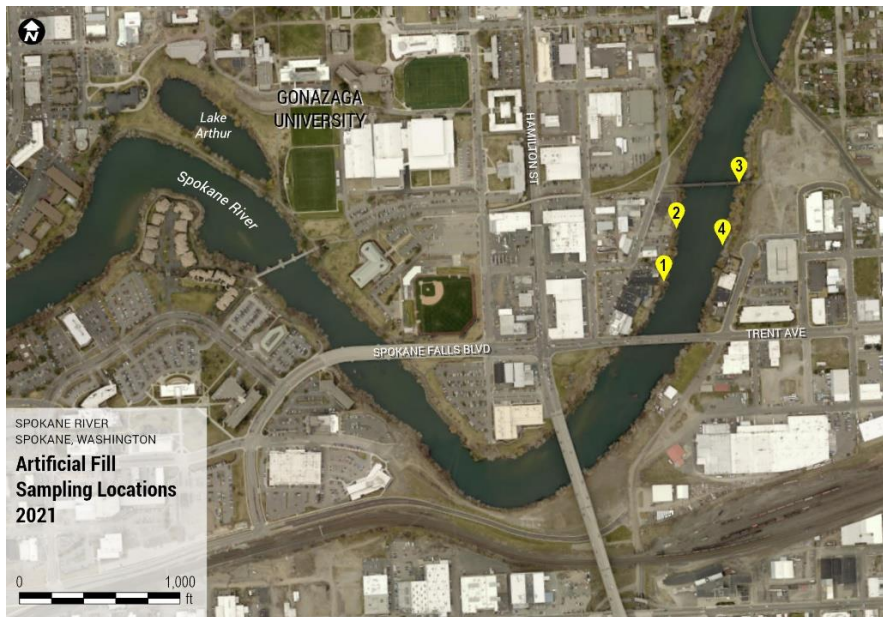
**Figure 1. Map of Sampling Area Locations**

Sampling locations consisted of four different areas within the Mission Reach, described in Table 1 and shown in Figure 1.

Area Number	Location Descriptor	Latitude	Longitude
1	Behind Northern Lights Brewing	47.66286° N	-117.39339° W
2	Right bank halfway between Northern Lights Brewing and foot bridge	47.66378° N	-117.39315° W
3	Left bank near foot bridge	47.66448° N	-117.39138° W
4	Left bank across from Northern Lights Brewing	47.66344° N	-117.39193° W

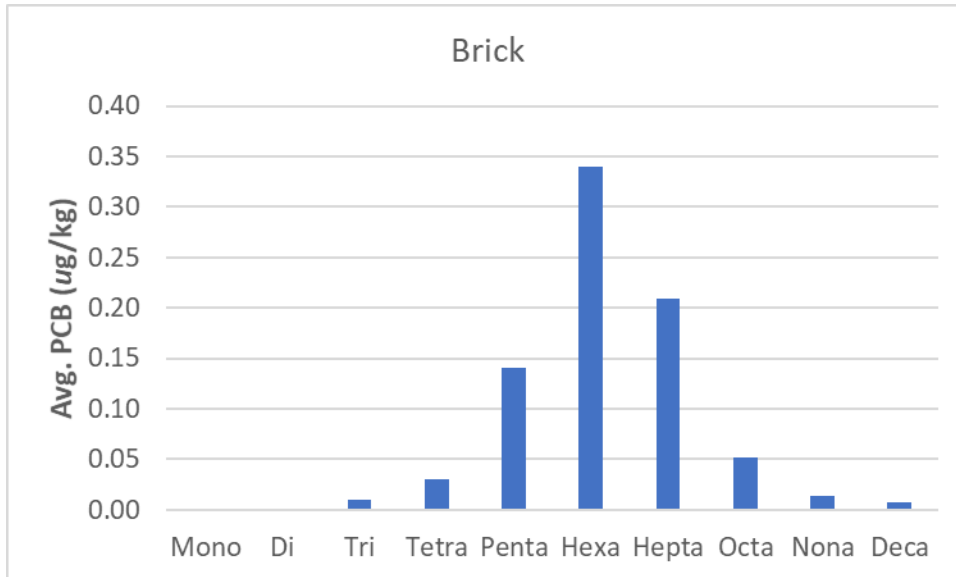
Figure 3. Average Blank-Corrected Homolog Concentrations for All Brick Samples.

Homolog distributions are provided in Figures 3 through 5, showing average concentration by homolog across all samples for each substrate type. These data are provided in tabular format for each individual sample in Appendix A. Concentrations in brick and asphalt are dominated by the hexa-chloro homolog, while concentrations in concrete are dominated by the penta-chloro homolog.

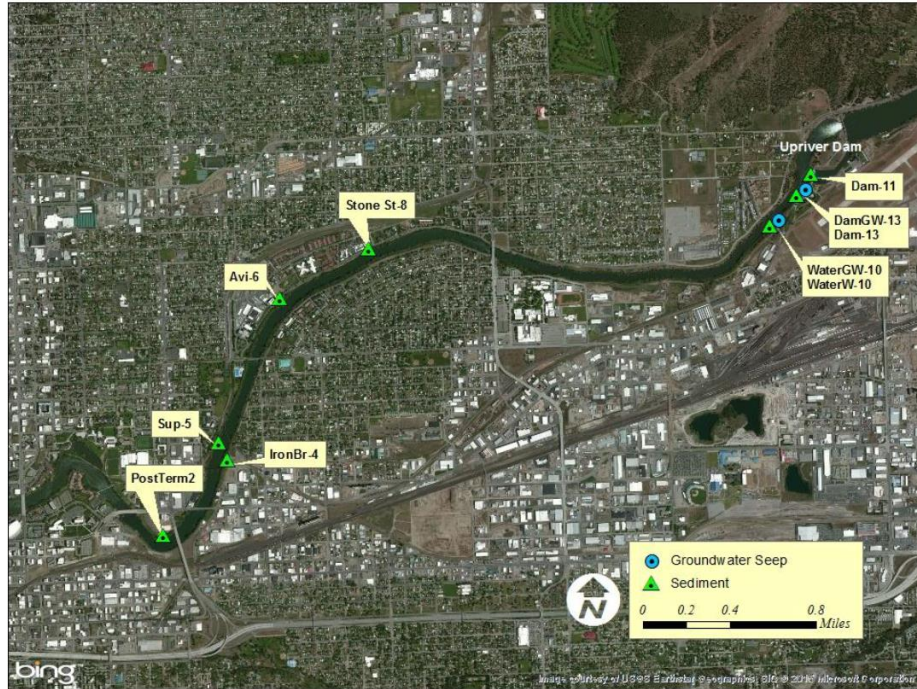
Figure 6. Ecology's Urban Waters Program 2013 Sediment Sampling Locations (from Era-Miller, 2015)

Ecology's Urban Waters Program sampled PCB content in Spokane River bottom sediments at eight locations in August 2013 (Figure 6). Seven of the stations were located upstream of the peak observed biofilm PCB concentrations, with the eighth location (named PostTerm2) located within the Mission Reach hot spot area.
