Analysis of Data in Mission Reach by Source/Pathway

SRRTTF-TTWG Data Synthesis Workshop

January 31, 2022

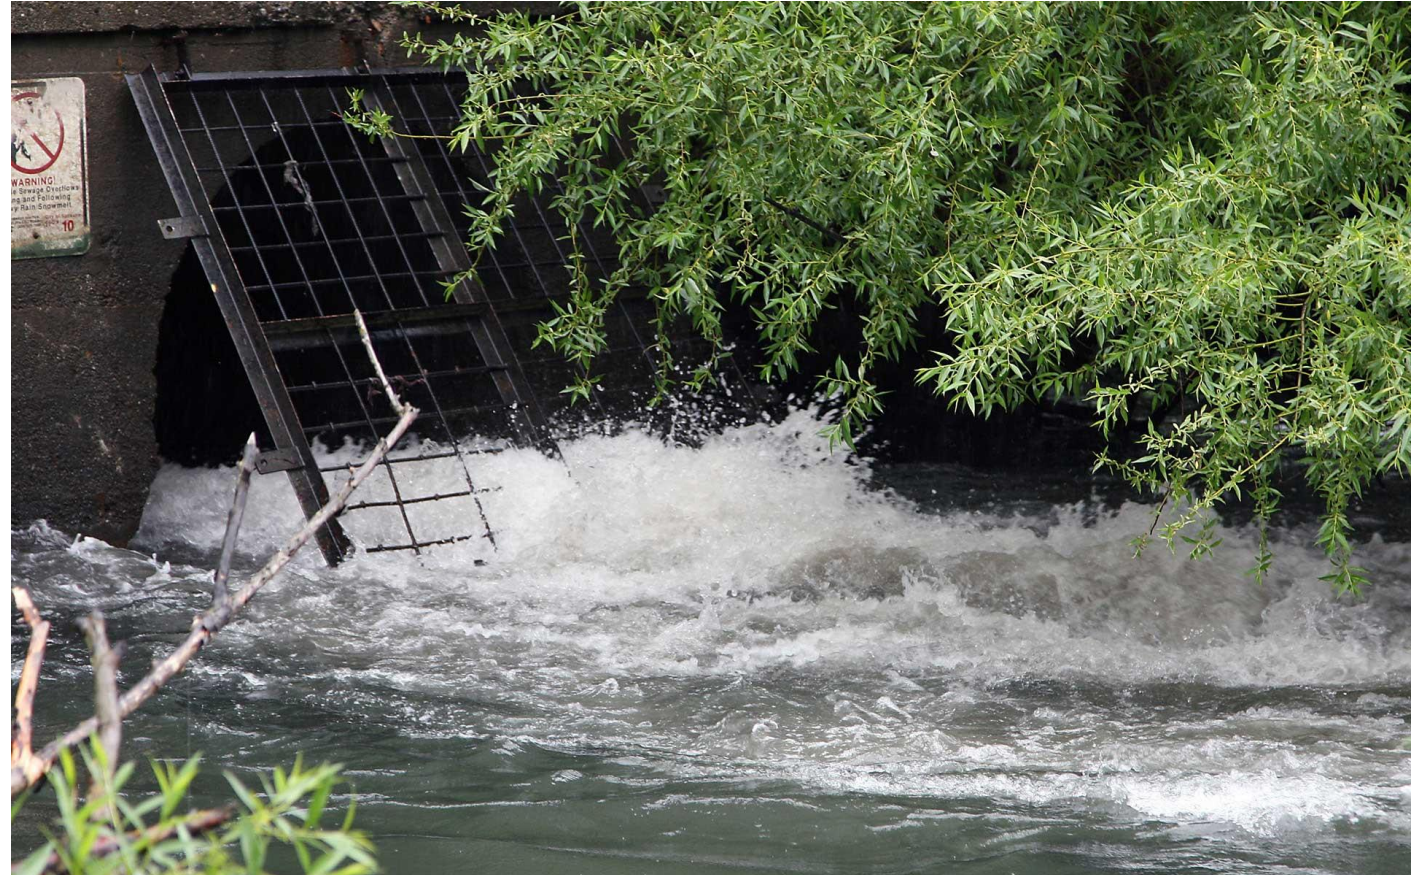
Landside Surface Contamination

- PCB-contamination in the contributing watershed is discharged to the Mission Reach via stormwater

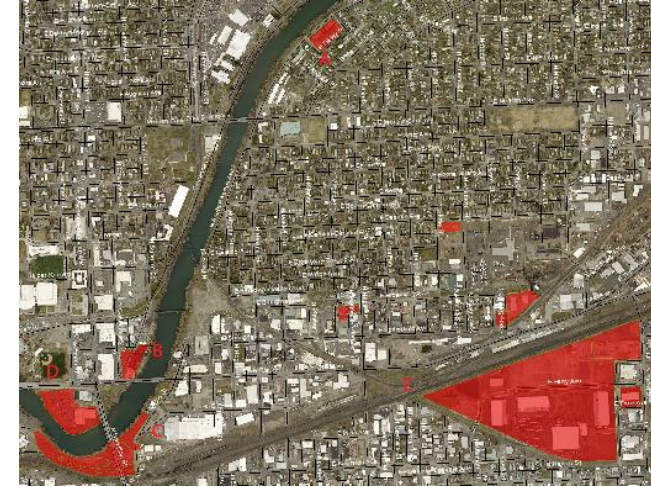
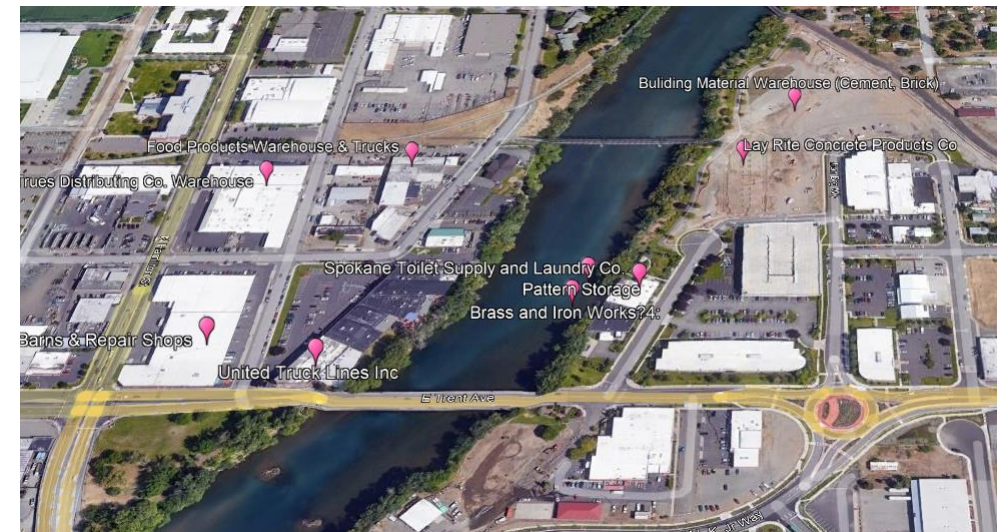
1. PCB contamination identified in the Mission Reach watershed

- Historical data
 - City of Spokane hazard assessment indicates areas of historical PCB contamination
 - Urban Waters program identified PCB contamination
 - Ecology review of Sanborn maps show historical presence of businesses potentially associated with PCB use

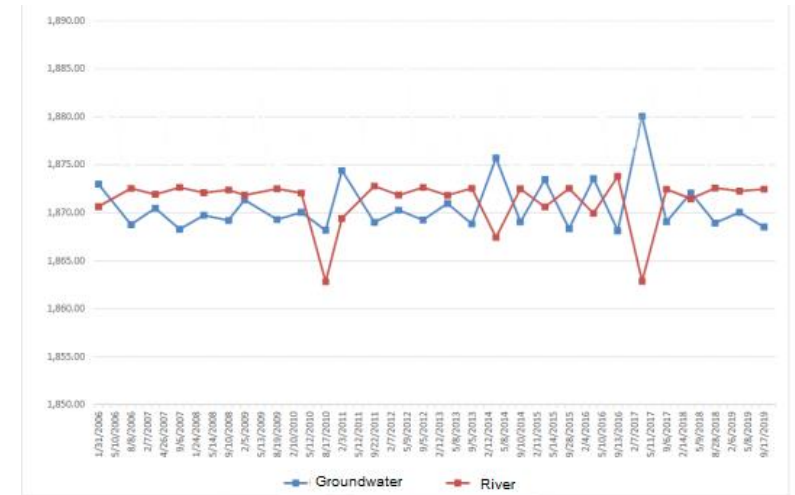
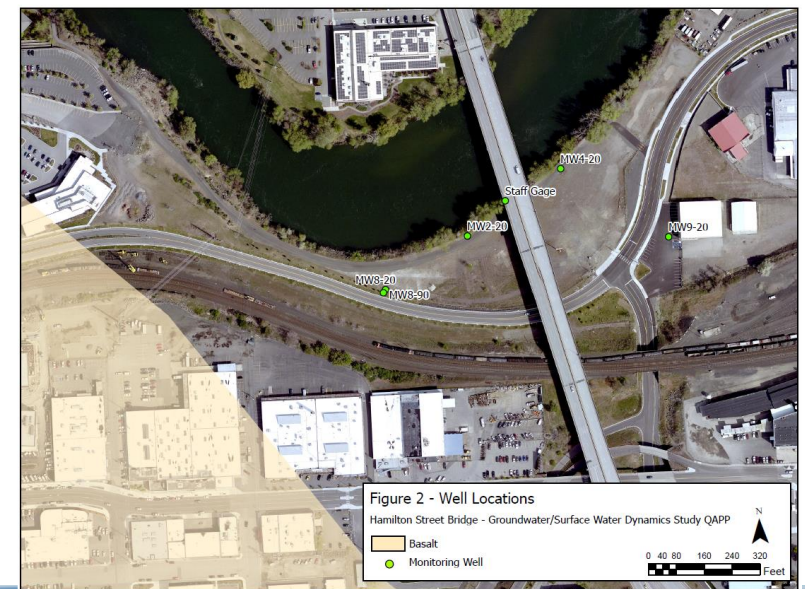
- Semi-annual river stage and groundwater elevation data from Hamilton Street show periods of time where groundwater elevation is higher than river stage
 - Indicates that the potential exists for groundwater to flow into river
- SRRTTF/Spokane County have initiated a study to continuously monitor groundwater elevation at multiple locations and surface water level at Hamilton Bridge

- Water movement is generally, but not always, from the river to the aquifer
 - Study is underway to provide more information on direction of flow
- Historical land use activities are conducive to groundwater contamination
- Artesian well sample from 2021 suggests groundwater contamination exists

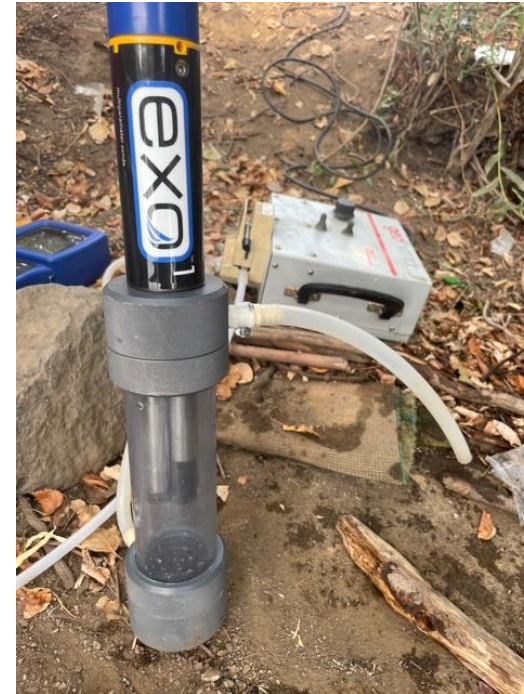
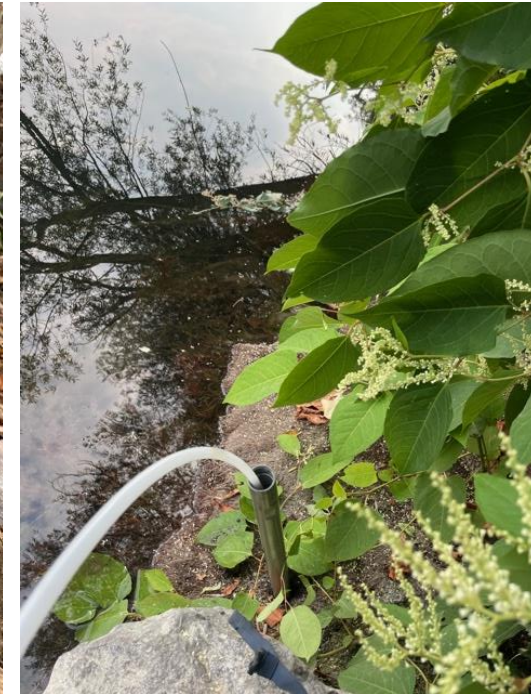
Piezometer feasibility assessment

- The feasibility of using temporary drive point piezometers to measure groundwater quality directly adjacent to the Mission Reach was tested in summer of 2021
 - Piezometers successfully deployed at two of three sites to measure temperature and conductivity
 - Could theoretically be deployed to measure groundwater PCB concentrations

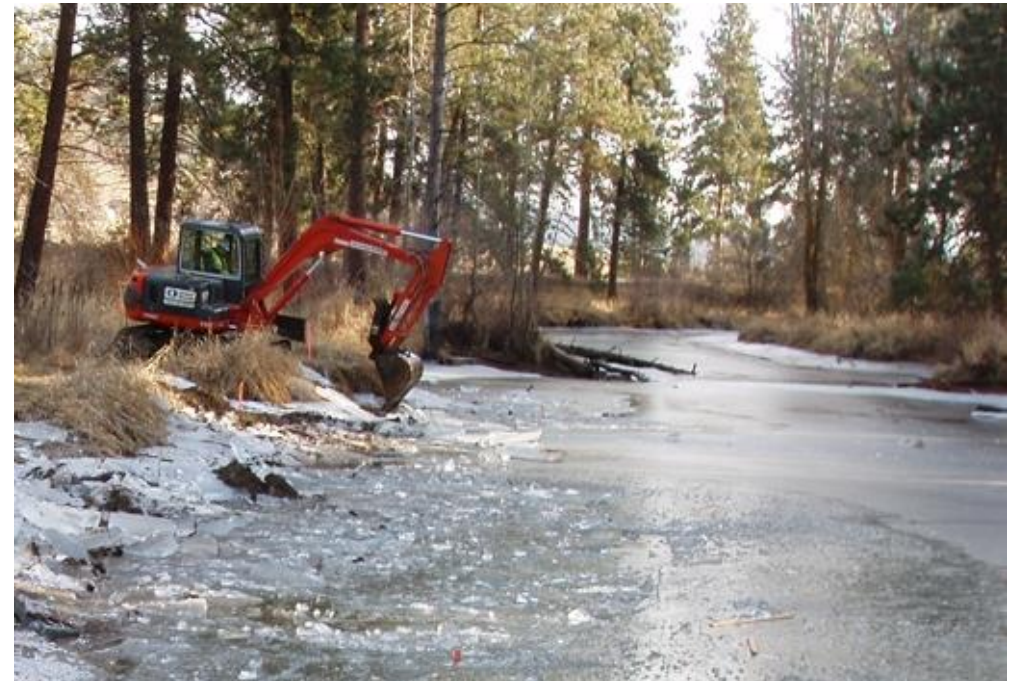
- Historically high levels of PCBs in the Spokane River could still reside in bedded sediments of Mission Reach
- Legacy sediment contamination was identified as an issue (and remediated) at sites upstream of Mission Reach
 - Surficial sediment PCB concentrations of up to 5,000,000 PPTr at Upriver Dam and Donkey Island

- Conclusions
 - Sediment PCB concentrations are elevated at certain sites in the Mission Reach
- Key data gaps
 - What is the spatial extent of the elevated sediment concentrations?
 - Are the elevated concentrations caused by legacy contamination from upstream sources or from a localized source within Mission Reach?
 - What is the environmental significance of these concentrations?
- Potential studies to fill gaps
 - Mapping of the areal extent of depositional areas
 - Sediment PCB monitoring with higher spatial resolution
 - Others?

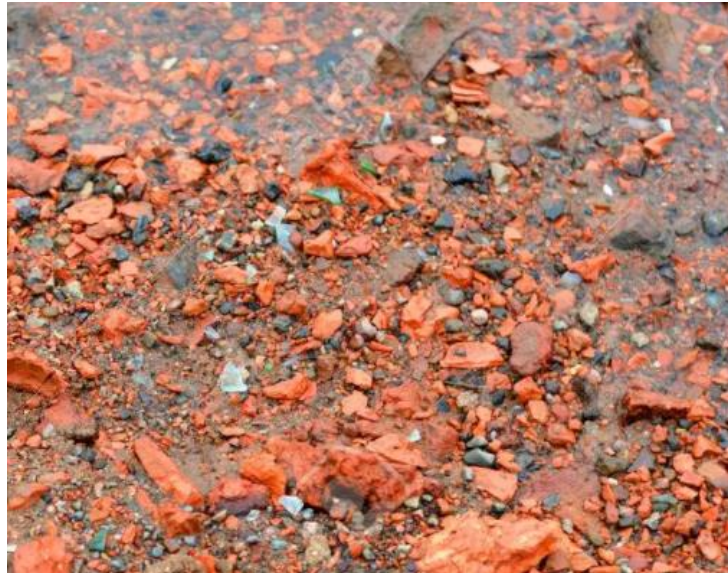
- Spokane River bottom in Mission Reach has large amounts of brick and concrete

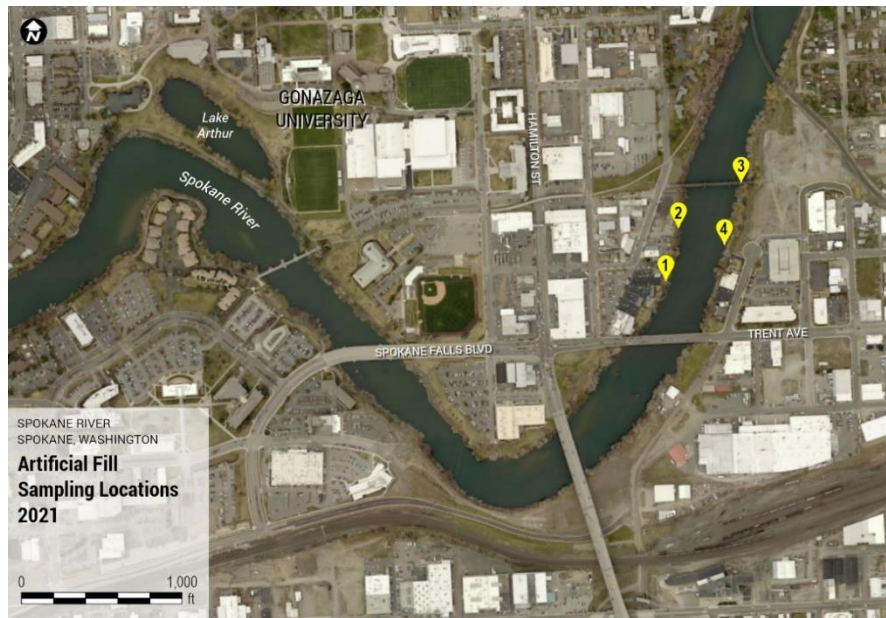
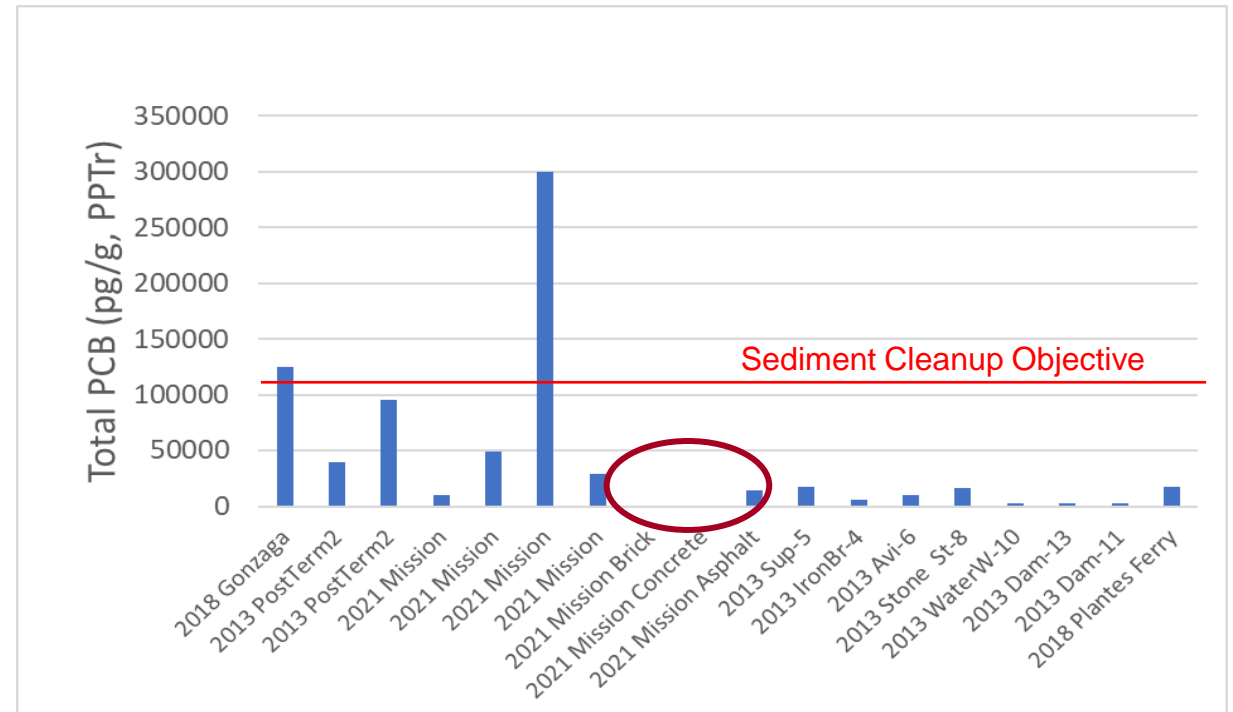
- Targeted sampling of brick, concrete and asphalt in Mission Reach

- PCB-concentrations in artificial fill are at or below ambient levels

- Conclusions
 - Available data shows negligible amounts of PCBs in artificial fill material
- Key data gaps
 - Existing sampling was not comprehensive in terms of number of locations
- Potential studies to fill gaps
 - Additional monitoring with greater spatial coverage of artificial fill PCB concentrations
 - Others?

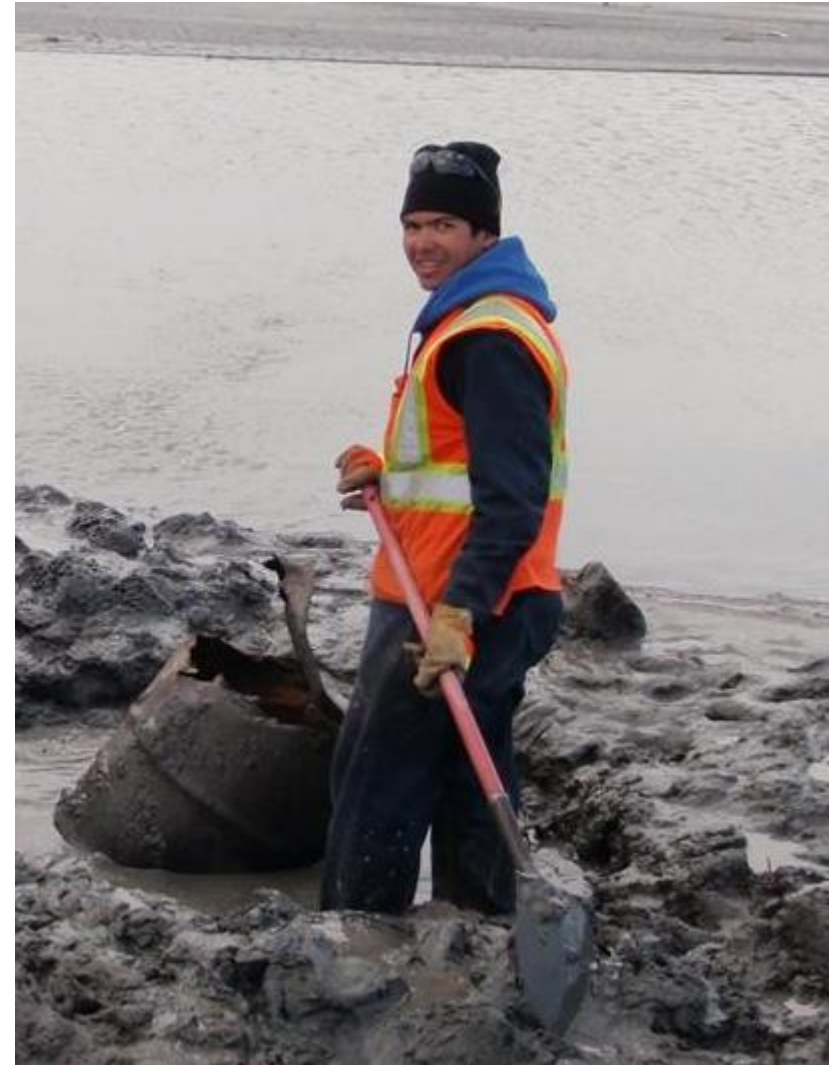
- Objects containing high concentrations of PCBs (e.g., drums, transformers) could be buried in the riverbed
 - Prior evidence of a buried drum near Spokane Falls Blvd.
- The patchy nature of observed sediment and biofilm contamination is consistent with a very localized source such as a buried object

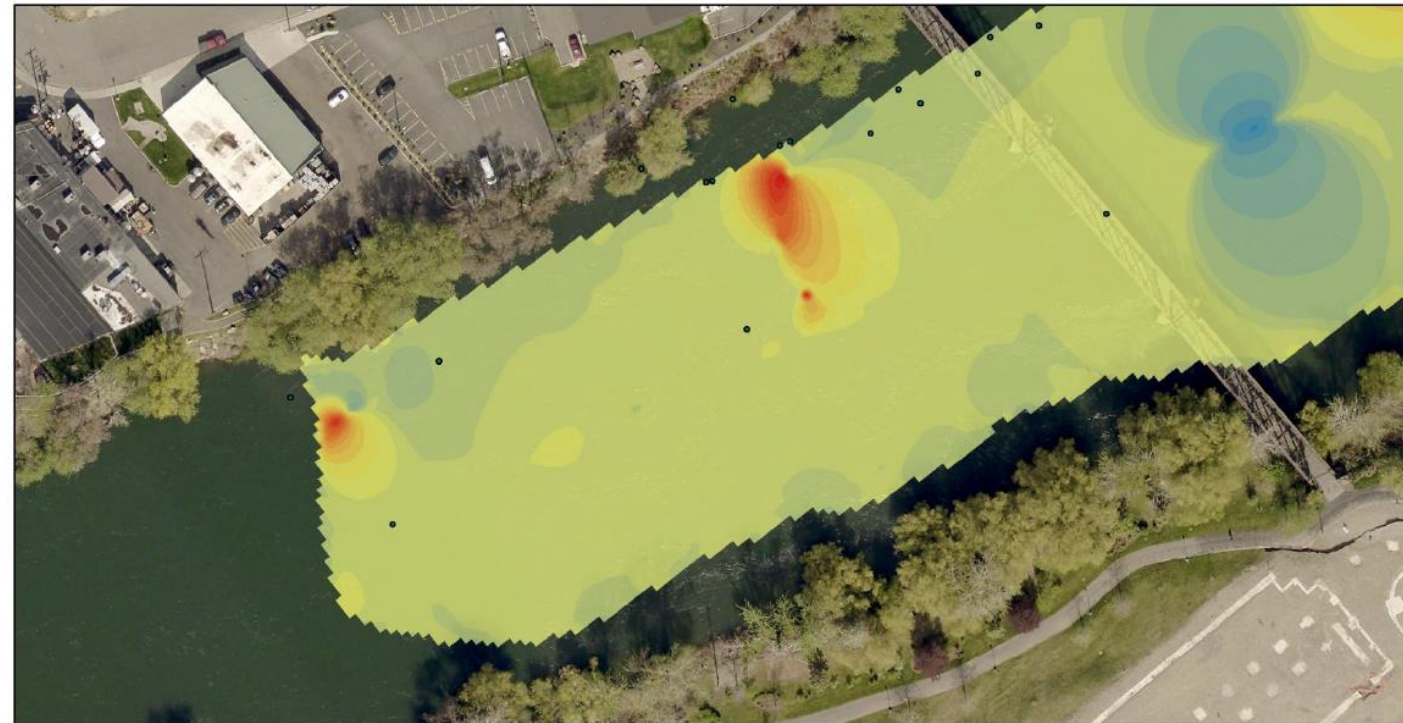
- 2021 object detection survey conducted by Gravity shows presence of magnetic anomalies in the riverbed
 - Indicative of buried metallic objects

- Conclusions
 - Magnetic anomalies indicative of buried metallic objects have been identified in the Mission Reach
- Key data gaps
 - What do these anomalies represent?
- Potential studies to fill gaps
 - Follow-up via video or diver survey to positively identify objects
 - Others?
