Monitoring to Assist in Defining the Sources of PCB Contamination in the Mission Reach

Spokane River Toxics Task Force Meeting
March 23, 2022

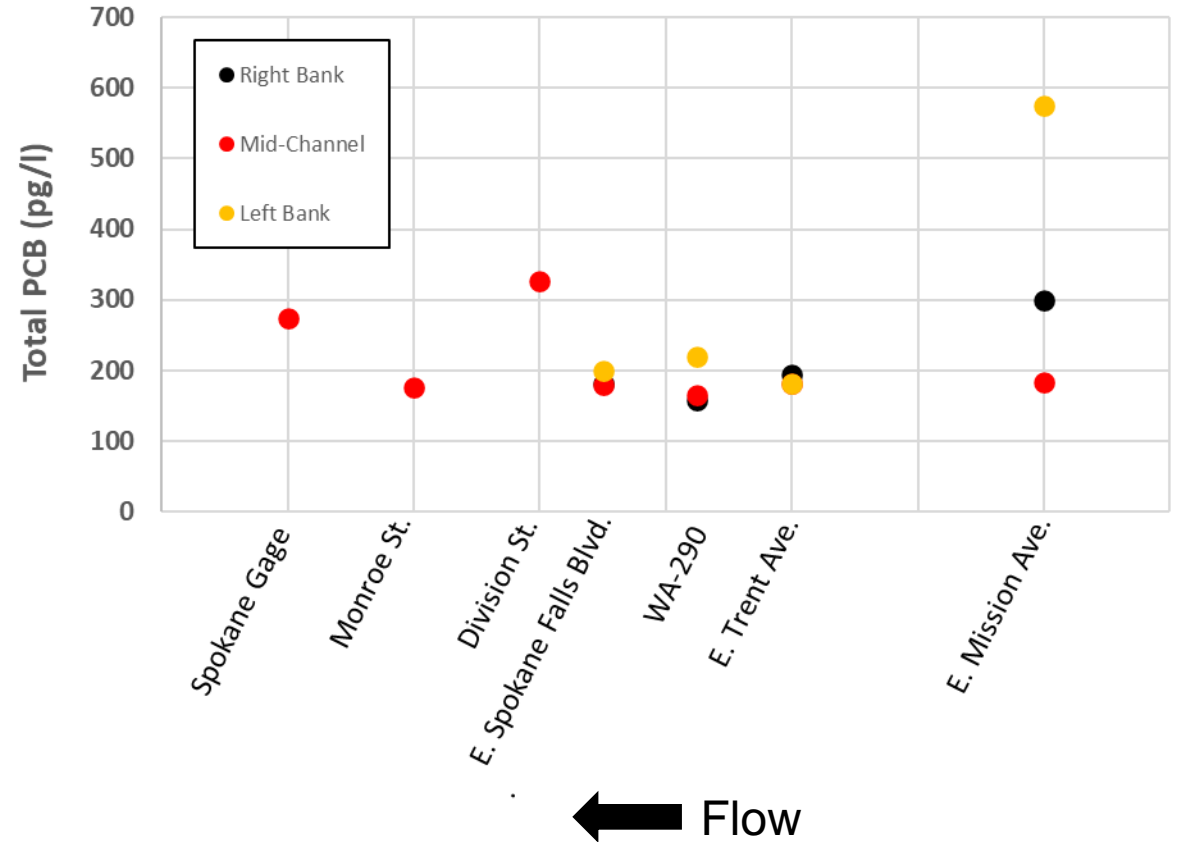
Water Results: Total PCBs

- Concentrations generally range between 150 and 320 pg/l
- No obvious spatial pattern indicating presence of a PCB source
- Elevated concentration observed at E. Mission Ave. (574 pg/l)
 - Source (if any) upstream of Mission Reach

- PCB concentration = 2100 pg/l

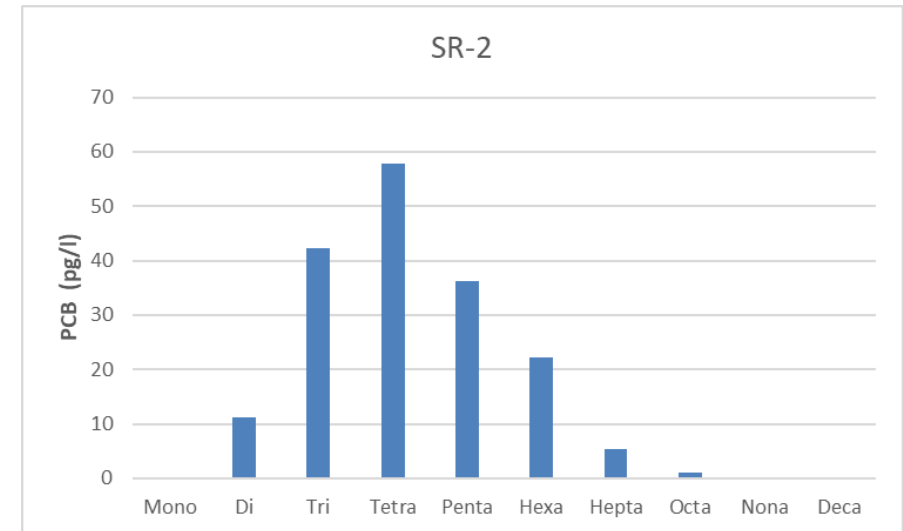
- Tetra- most prevalent, followed by tri- and penta-chloro homologs
- Potentially indicative of a mixture of Aroclor 1242 and 1254

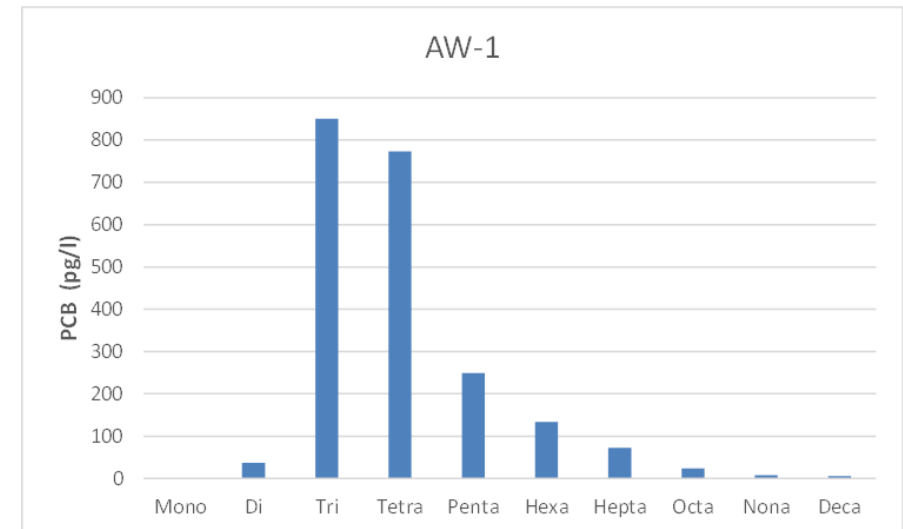
- Dominated by tri and tetra-chloro homologs
- Very similar to Aroclor 1242

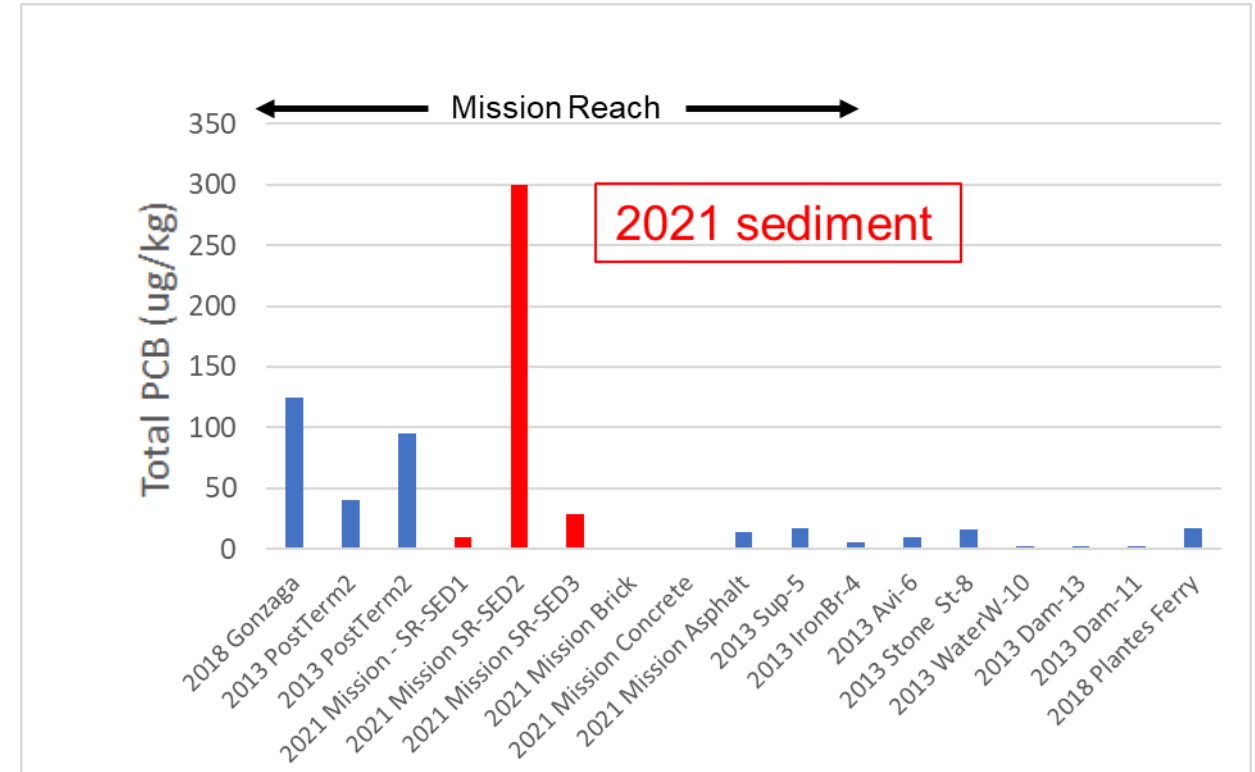
Sediment Results: Total PCBs

- Consistent with historically observed patterns
 - One elevated (300 ug/kg) concentrations
 - Two concentration similar to those seen outside of Mission Reach

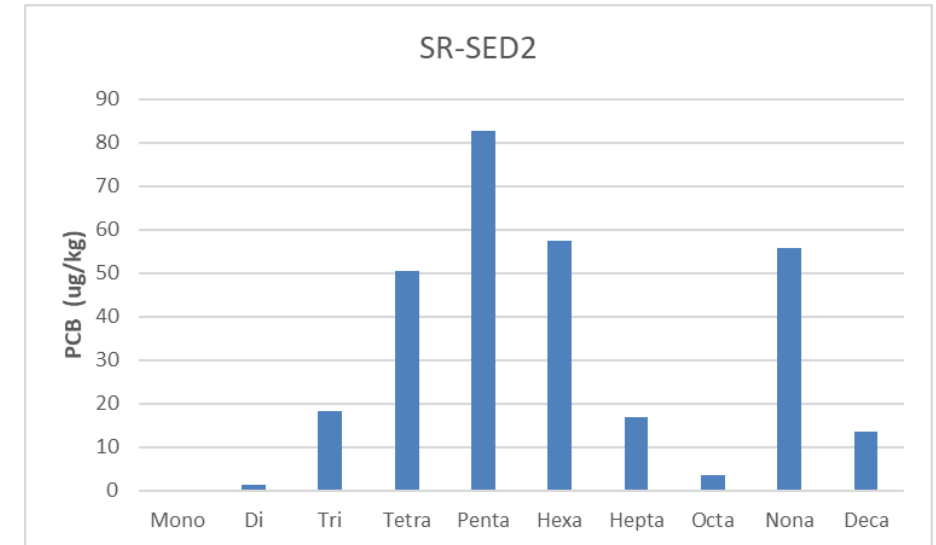
Sediment Results: Homolog Distributions

- Elevated sample
 - Penta- most prevalent, followed by hexa- nona- and tetra-
 - Does nona- signal represent a Galbestos (Aroclor 1268) source?

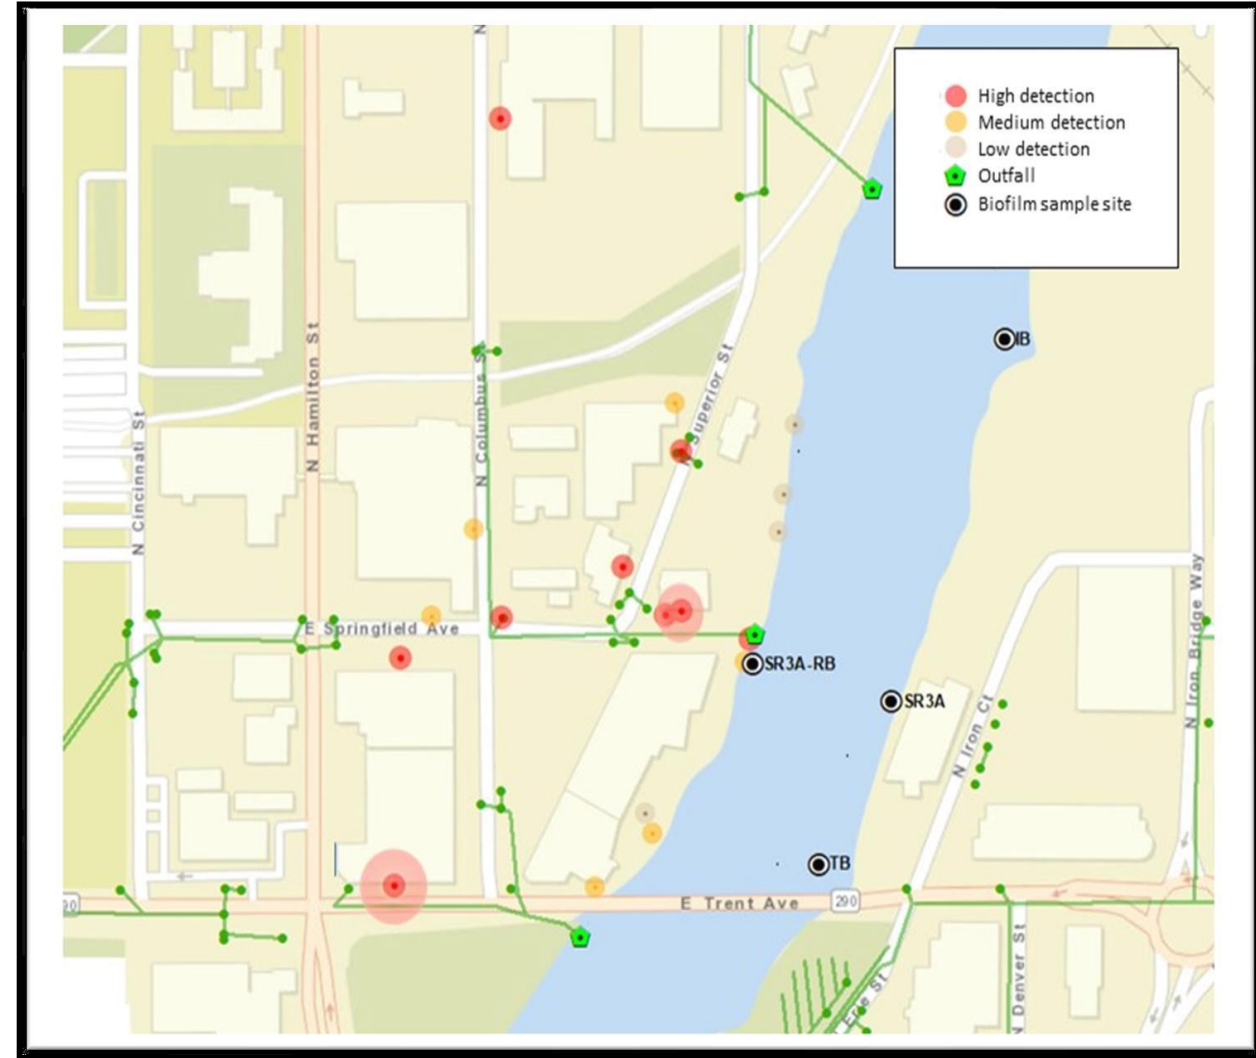
- No definitive sources of PCBs detected along riverbank
- Detections were observed at
 - several buildings
 - stormwater catch basin sites
 - drywell sites
- Sampling to be recommended at catch basins
 - Follow-up monitoring contingent upon those results

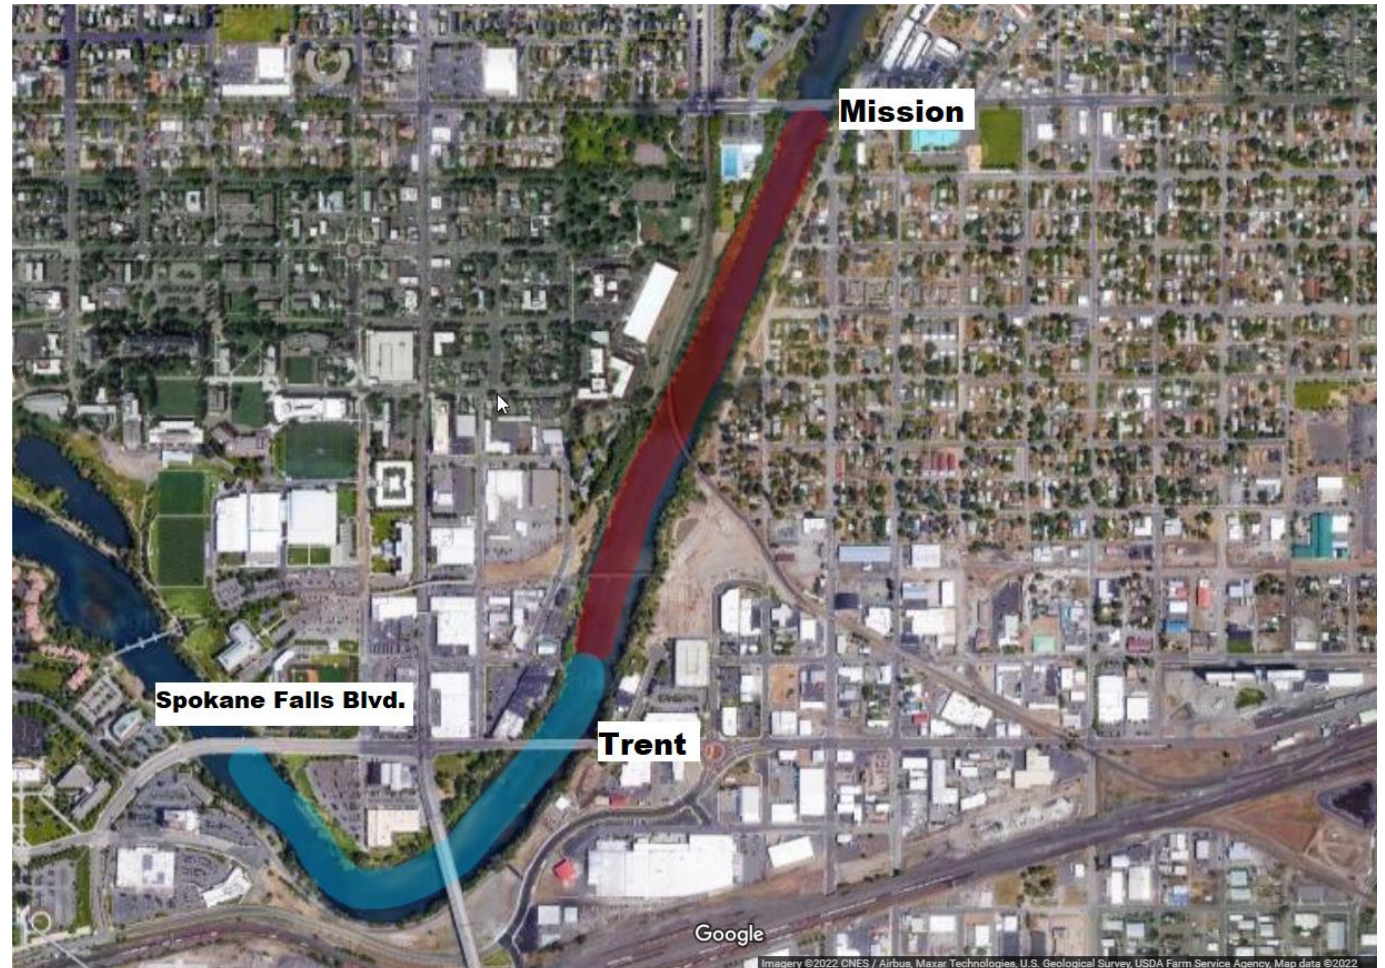
Object Detection Results

- Entire Mission Reach could not be surveyed due to construction at Trent Bridge

Monitored in 2021

To be monitored in 2022

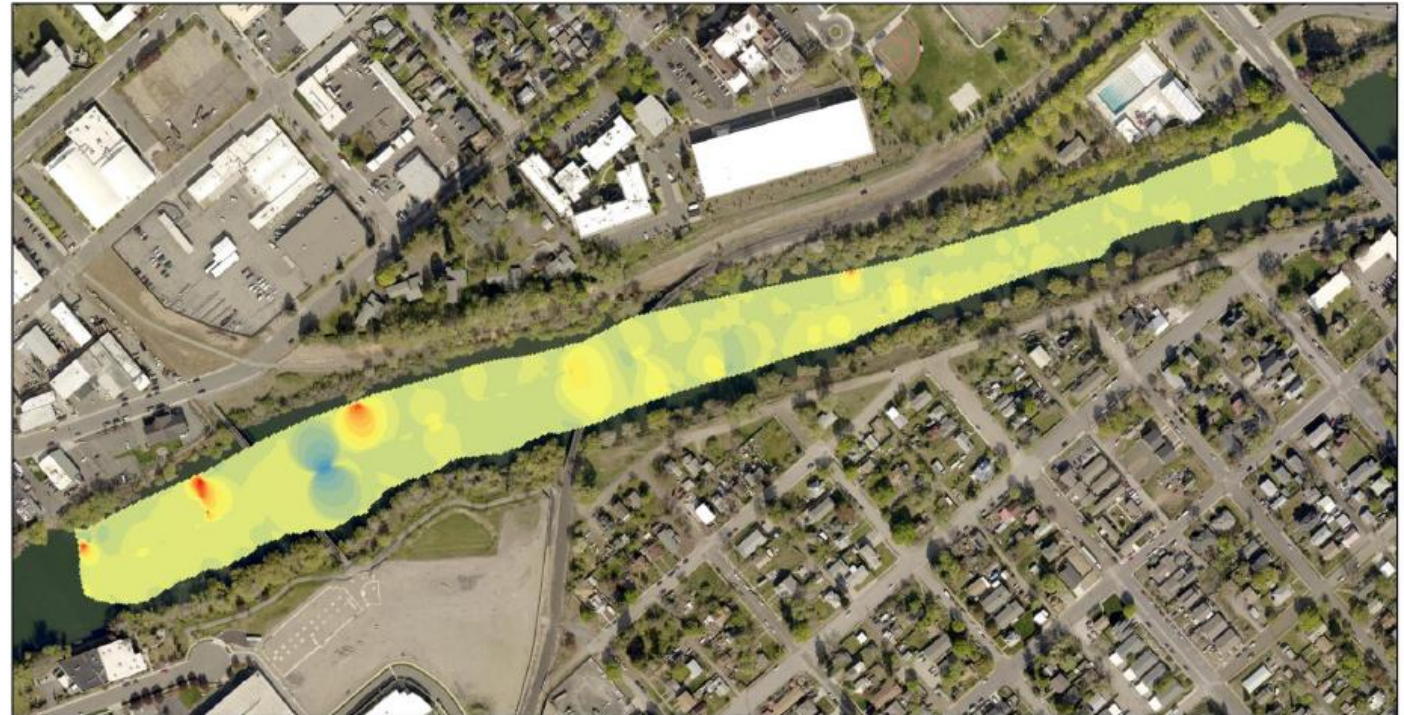
- Areas of contamination identified in lower portion of surveyed area

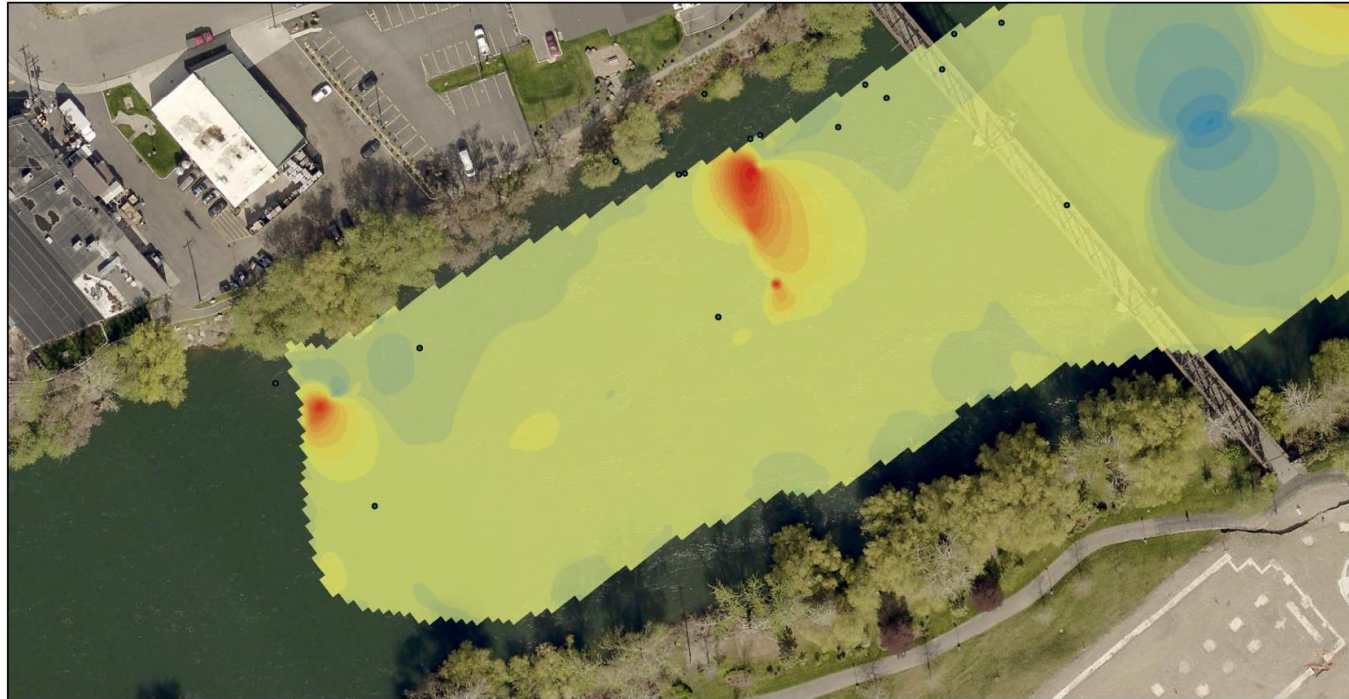
- Three metallic objects identified in downstream portion of surveyed area
