Monitoring to Assist in Defining the Sources of PCB Contamination in the Spokane River Mission Reach

Prepared for:
Spokane River Regional Toxics
Task Force

~~March 10~~April 14, 2022
TTWG Review DRAFT

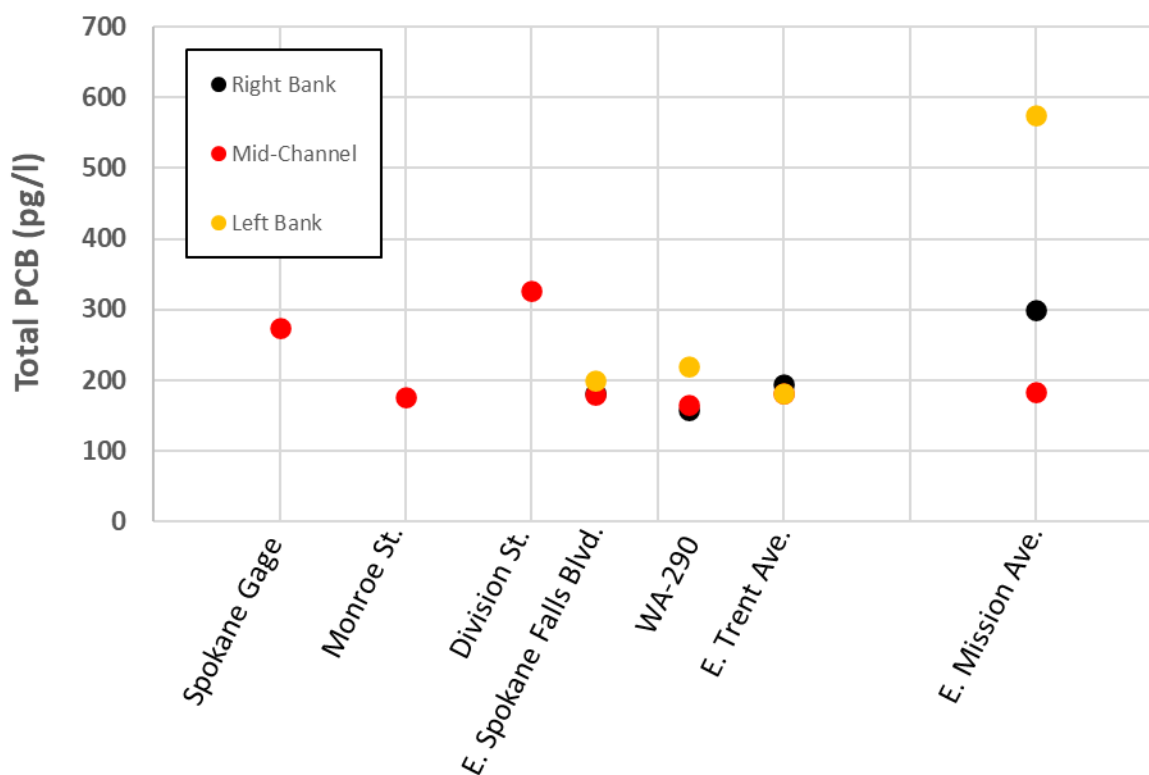
Figure 2. Water Column Total PCB Concentrations (pg/l)

Total PCB concentrations for the water column and artesian well sampling are provided in Table 2 with water column data plotted in in Figure 2. River PCB concentrations throughout the Mission Reach and downstream generally fall in 170 to 270 pg/l range with no obvious spatial pattern to indicate the presence of a water column PCB source within Mission Reach. The concentration observed at the left bank at E Mission Ave. (574 pg/l) was well above this range. This elevated concentration is not assumed to reflect a PCB source within Mission Reach, because this location is defined as the upstream boundary of Mission Reach. To the extent that this elevated concentration reflects an unknown source, that source would be located upstream of Mission Reach.

Water column grab sampling in the Mission Reach and downstream areas showed no spatial pattern indicative of an external source of PCBs to the water column. One elevated concentration of 574 ug/l was observed at E. Mission Ave. This location represents the upstream boundary of the Mission Reach so this elevated concentration represents a PCB source upstream of the Mission Reach. The tetra-chloro homolog was the most prevalent at the majority of locations, with tri- and penta-chloro homologs the next most abundant, potentially indicating a mixture of Aroclors 1242 and 1254. The E. Mission Ave Bridge and Spokane Gage stations had a relatively higher percentage of penta- and hexa-chloro homologs, potentially indicating a larger proportion of Aroclor 1254.

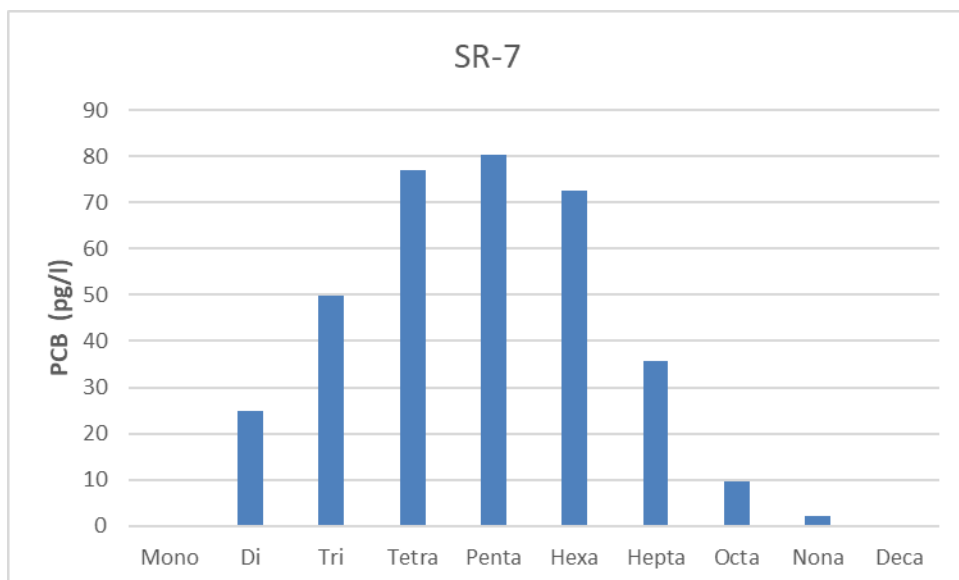
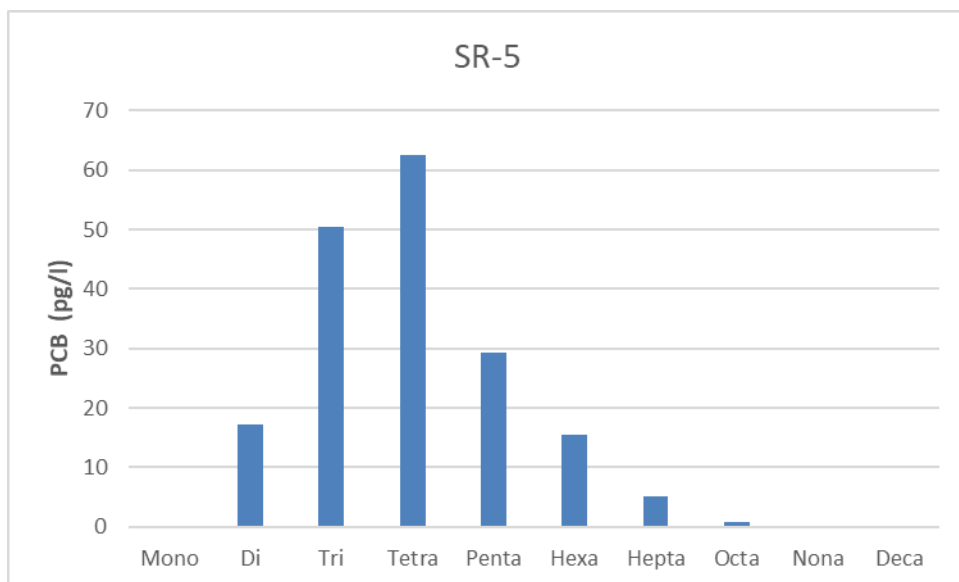
Homolog distributions for river water column samples are provided in Figures 3 through 9. These data are provided in tabular format for each individual sample in Appendix A. The tetra-chloro

homolog was the most prevalent at the majority of locations, with tri- and penta-chloro homologs the next most abundant. Two locations exhibited congener distribution distinct from the above pattern. The E. Mission Ave Bridge and Spokane Gage stations had a relatively higher percentage of penta- and hexa-chloro homologs.

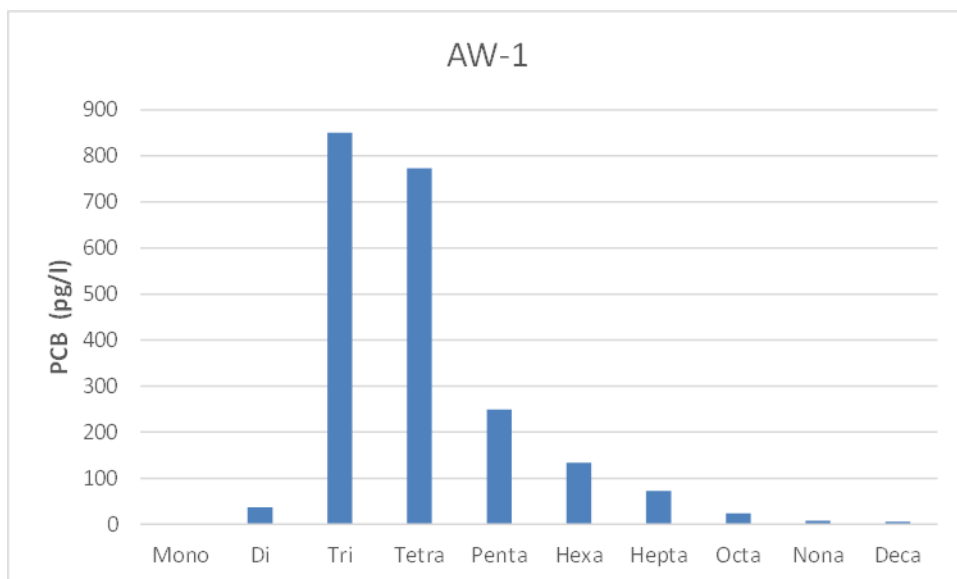
Figure 10. Blank-Corrected Homolog Concentrations for Artesian Well Sample

Figure 10 shows the homolog distribution for the artesian well sample. These data are provided in tabular format in Appendix A. The tri- and tetra-chloro homologs dominate the total concentration, potentially indicative of an Aroclor 1242 source. [A cosine similarity analysis between the Artesian Well sample and Aroclor 1242 resulted in a value of 0.91. A cosine similarity analysis between the Artesian Well sample and Aroclor 1016 resulted in a value of 0.89.](#)

The PCB concentration in an artesian well discharging into the downstream section of the Mission Reach was greater than 2000 ug/l. This suggests that contaminated groundwater could be contributing to the elevated Mission Reach PCB concentrations. The tri- and tetra-chloro homologs dominate the total concentration, potentially indicative of an Aroclor 1242 source.

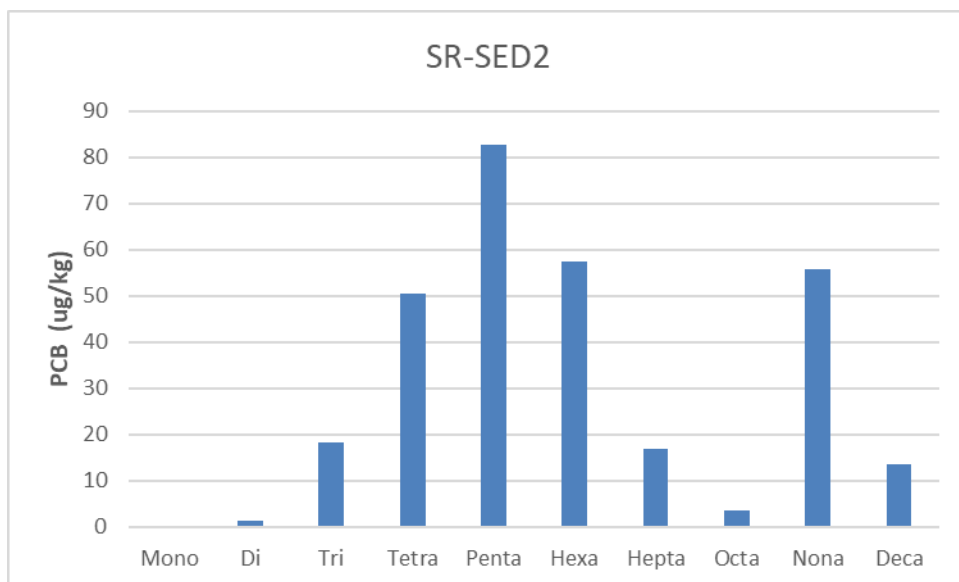
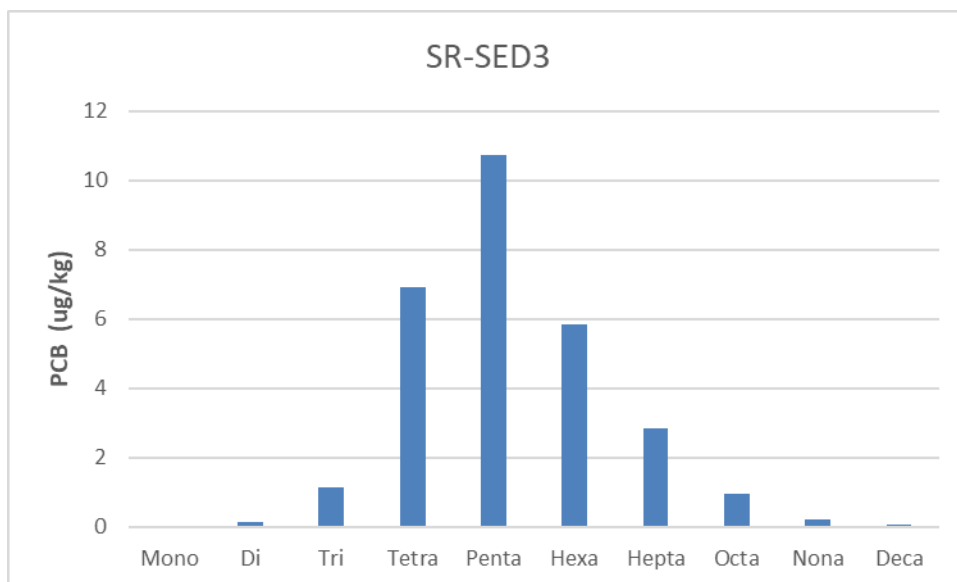
Figures 11 through 13 show the homolog distribution for each of the sediment sampling locations. These data are provided in tabular format for each individual sample in Appendix A. The penta-chloro homolog was the most prevalent at each location, with tetra- and hexa-chloro homologs the next most abundant. [Sample SR-SED2 also showed significant levels of nona-](#)

chlorinated (56 ug/kg) and deca- chlorinated (14 ug/kg) homologs, potentially indicative of a contribution from an Aroclor 1268 source.

All three locations had highest concentrations in the penta-chloro homolog, with station SR-SED2 showing high concentration in the nona-chloro homolog. Further investigation is needed to determine the source of this elevated concentration.

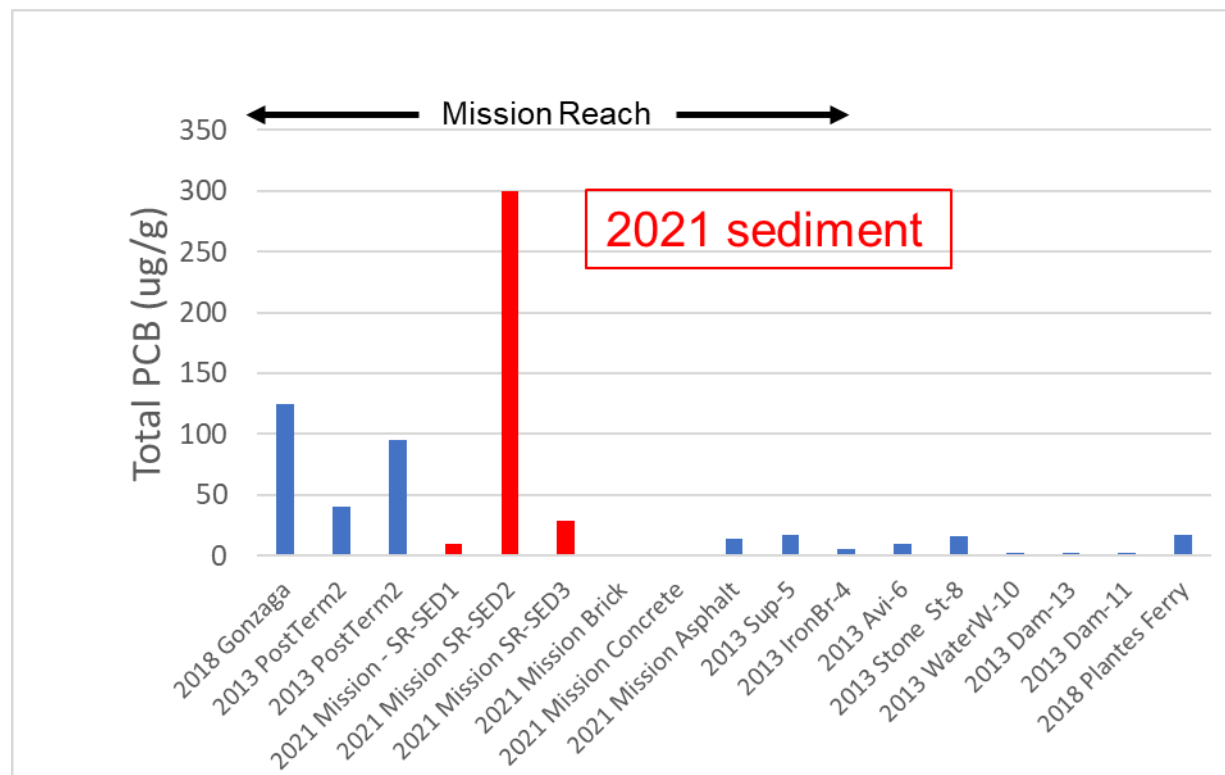
Figure 14. Comparison of Sediment PCB Concentrations Observed in this Study to Recent Task Force and Ecology Data

Sampling of PCBs in bottom sediments at three Mission Reach locations showed one site with elevated concentrations (300 ug/kg) and two sites with concentrations consistent with those observed elsewhere in the Spokane River. Figure 14 compares observed sediment concentrations from this study with prior Task Force (LimnoTech, 2021b) and Ecology (Era-Miller, 2020; Era-Miller, 2015) sediment PCB concentration observed within and upstream of the Mission

Reach. PCB concentrations in this study are consistent with the general pattern ~~those~~ observed previously, i.e., Mission Reach concentrations are highly variable, with the majority of samples having less than 30 ug PCB/kg but occasional samples greater than- 100 ug PCB/kg. The 2021 data are notable in the regard that the elevated concentration of 300 ug/kg is more than twice as large as any of the other recently observed sediment concentrations.

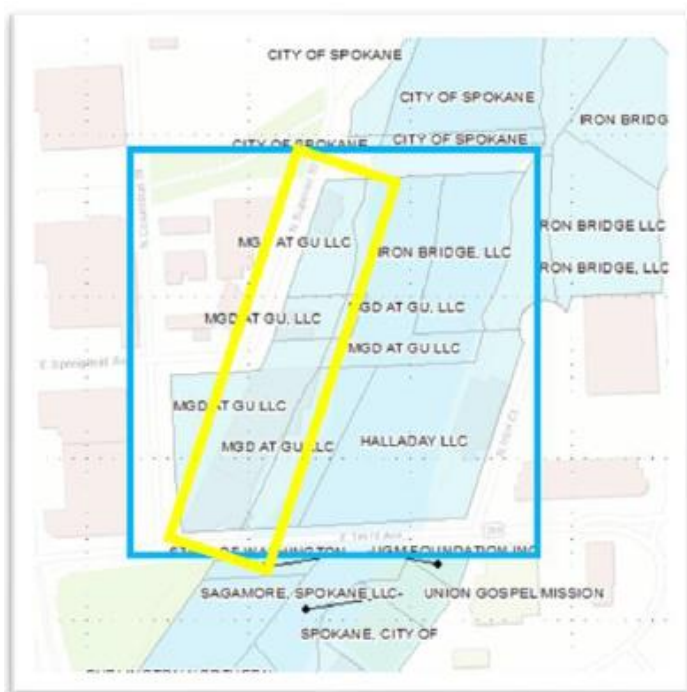
Figure 15. Target Area and Permissions

Canine surveys took place on August 29-31st 2021. The survey area was prioritized to the area between North Columbia Street (western perimeter) and Iron Bridge Court (eastern perimeter), the Iron Bridge (northern perimeter) and Trent Avenue (southern perimeter). The canine team was granted access to search the Riverwalk building on the right bank and properties owned by MGD LLC. (Figure 15). Canine and handler surveyed the priority area by searching both sides of the riverbank and by walking the perimeter of buildings and property lines within designated areas. Due to canine interest, surveys were extended westward to East Hamilton Street and north to East Cataldo Avenue Survey. Coverage was recorded using GPS track logger (Figure 16).

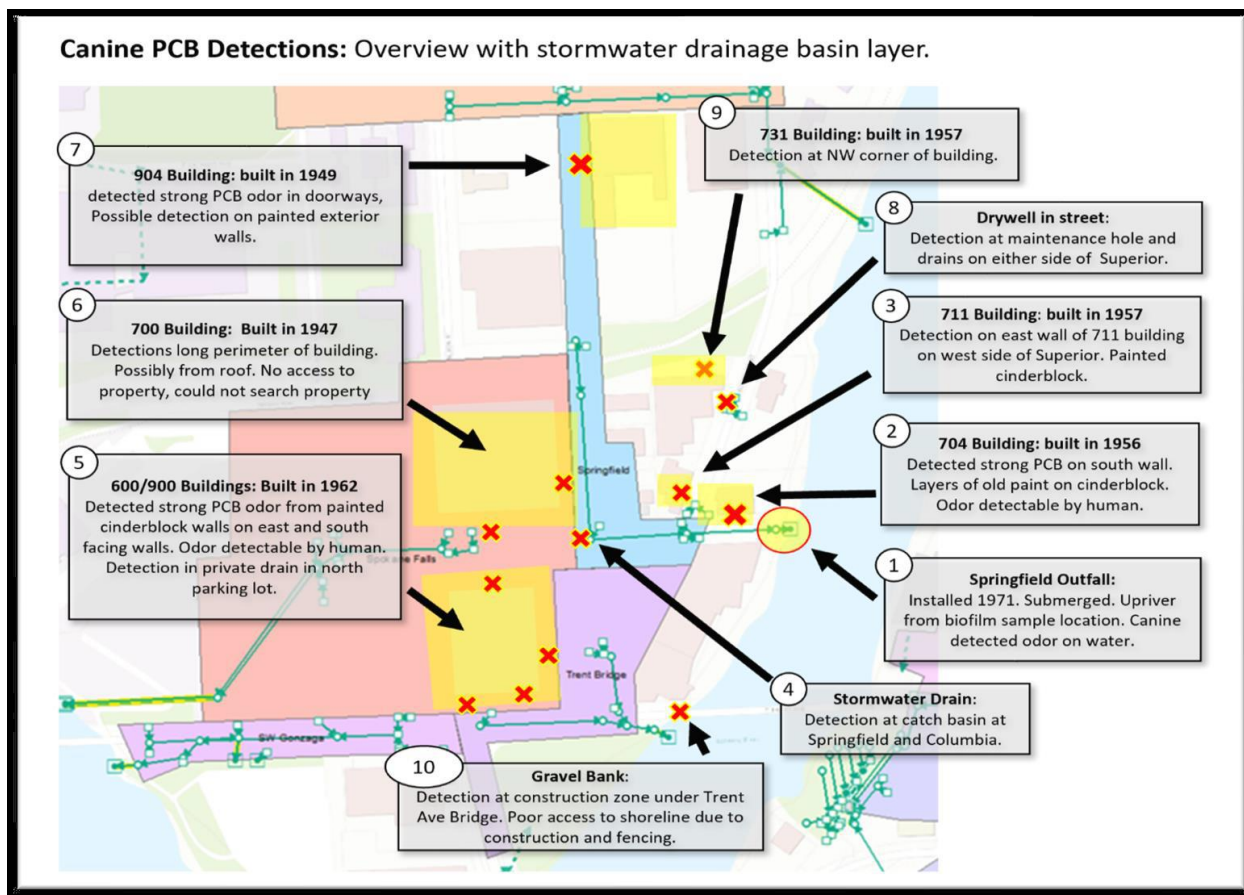
Figure 18. Overview of PCB Detection Sites.

There were 10 areas of high interest to the detection dog. Figure 18 above shows a summary of these 10 sites and the underlying stormwater system that drains directly into the Spokane River..

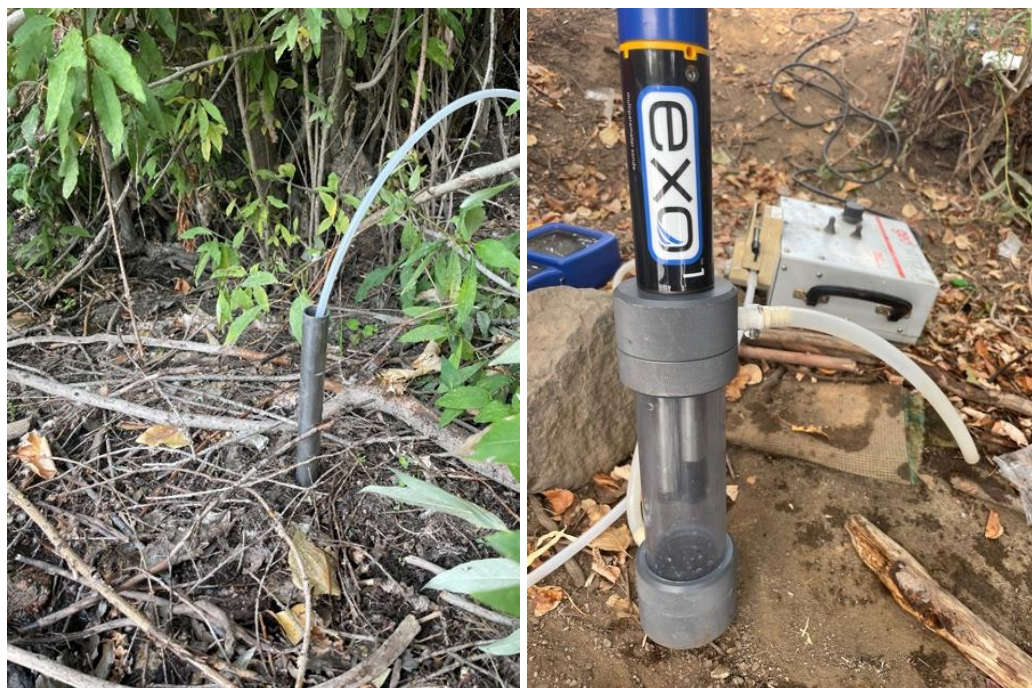
Figure 21. Installed piezometer system

Gravity Marine Consulting, LLC (Gravity) was contracted by the Task Force to conduct the feasibility assessment. Three sites were selected for this assessment, consisting of the near-shore area adjacent to the sediment sampling sites described previously in Table 1 of this report. Field methods were performed to be consistent with Standard Operating Procedure EAP061, Version 2.1: Installing, Monitoring, and Decommissioning Hand-driven In-water Piezometers (Sinclair and Pitz, 2018). Water collected from the piezometer were analyzed for temperature and specific conductivity. Concurrent sampling of temperature and specific conductivity were made of water in the Spokane River at each site. Figure 21 shows an example of an installed piezometer and YSI flow-through cell used to measure water quality.

Piezometers were successfully deployed at two of the three test sites, SR-SED1 and SR-SED3. The piezometer installed at site SR-SED2 was not able to collect a sufficient sample to allow water quality analysis. Table 4 shows the temperature and specific conductivity measured in both the surface water (i.e., river) and transition zone water for the remaining stations. Obvious differences in temperature and specific conductivity are observed between the surface water and transition zone water. These differences suggest that the water quality of the transition zone is influenced by more than just the surface water, indicating that groundwater may be flowing into the Mission Reach.
