Spokane River Regional Toxics Task Force 2022 Measurement of PCBs in Biofilm and Sediment in the Spokane River

Prepared for:
Spokane River Regional Toxics
Task Force

TTWG REVIEW DRAFT
May 19, 2023

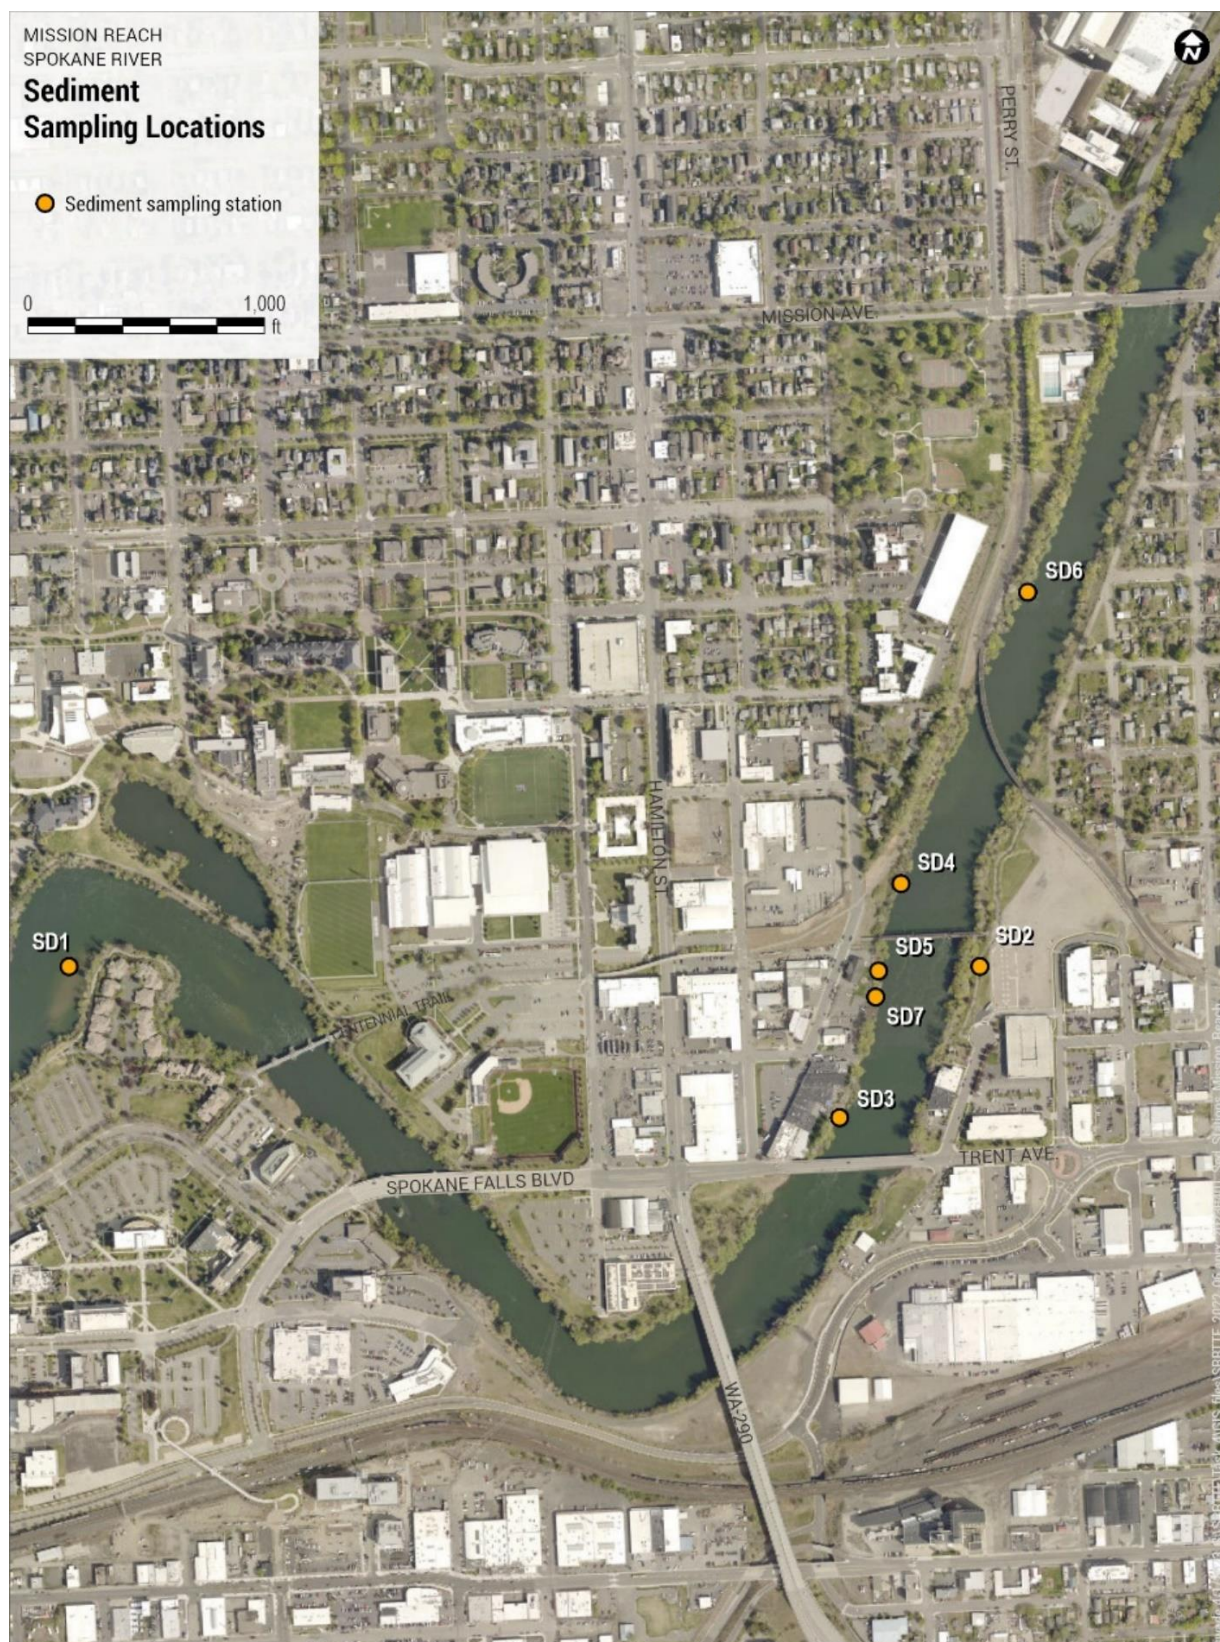
Figure 1. Map of 2022 Sediment Sampling Locations

Separate sampling locations were employed for sediments and biofilm. The locations for each are described below. Sediment sampling locations were selected to meet one of two criteria: 1) five locations immediately downstream of magnetic anomalies identified during the 2021 and 2022 object detection surveys, and 2) two locations previously identified as having elevated sediment PCB concentrations during the 2018 Ecology monitoring or 2021 Task Force monitoring. The locations immediately downstream of magnetic anomalies were selected to indirectly determine whether the identified metallic objects are contributing measurable levels of PCBs to the river. The two locations associated with historically high sediment concentrations are designed to confirm the continued presence of elevated concentrations. The specific locations are described in Table 1 and shown in Figure 1.

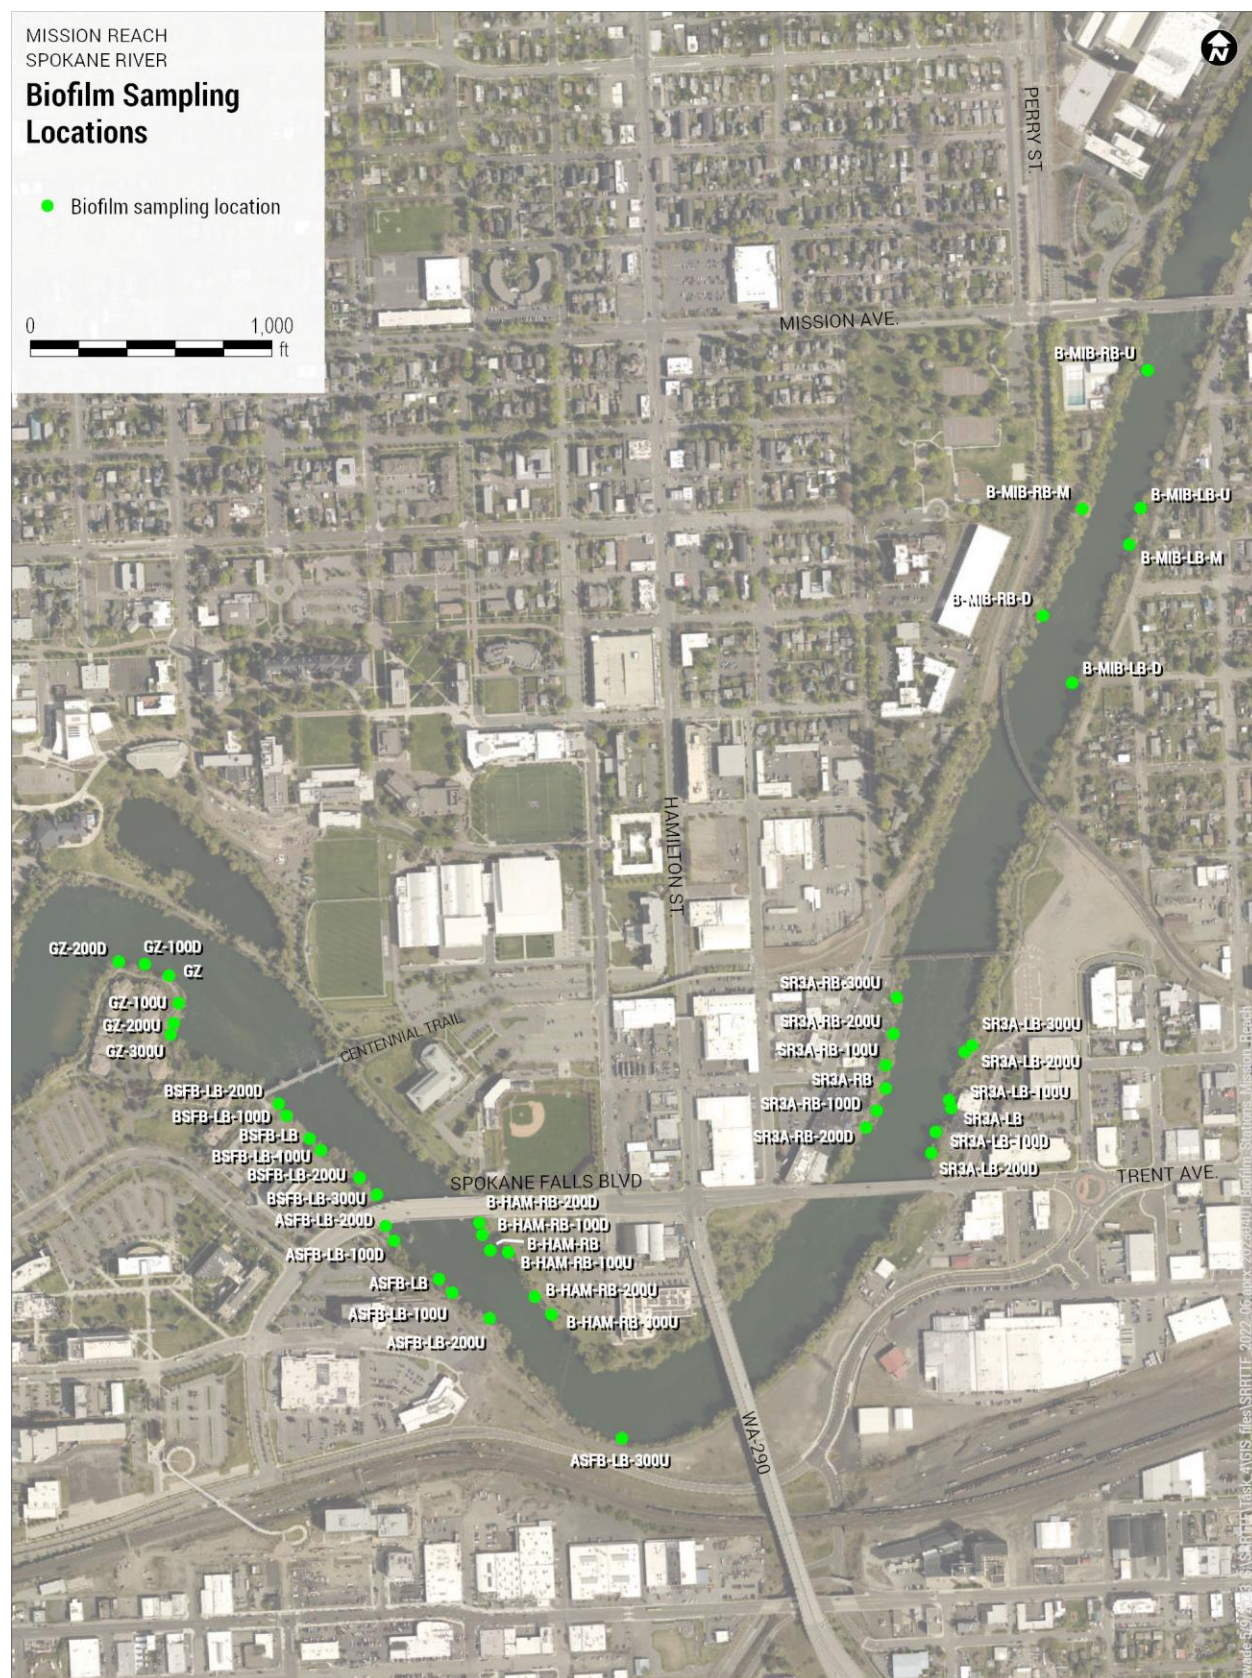
Figure 2. Map of 2022 Biofilm Sampling Locations

Biofilm sampling locations were defined in collaboration with the SRRTTF to provide high spatial resolution sampling at areas where elevated biofilm PCB concentrations were observed in 2018 and 2019. The general design was to sample six locations in direct proximity to each of the seven locations where Ecology and observed elevated concentrations. Some locations were moved at the time of sampling due to unsafe access relating to steeply sloped banks or homeless encampments. A few other locations were moved due to limited biofilm availability which generally occurred in heavily shaded areas. Specific sampling locations are listed in Table 2 and mapped in Figure 2.

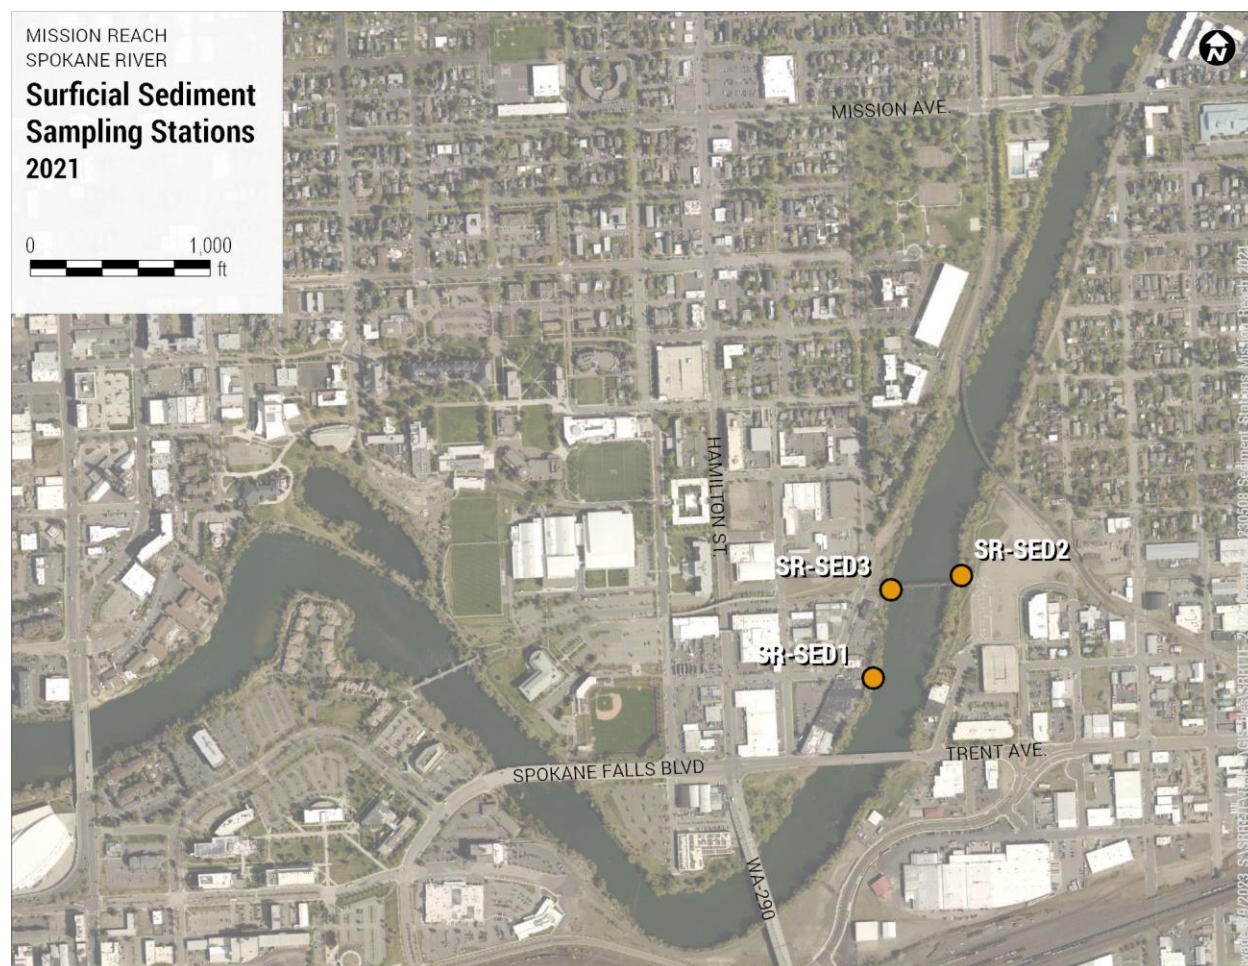
Figure 7. Mission Reach Sediment Stations Monitored in 2021

The Task Force also conducted limited sediment monitoring in the Mission Reach in 2021 (LimnoTech, 2022c) with three stations sampled as shown in Figure 7.

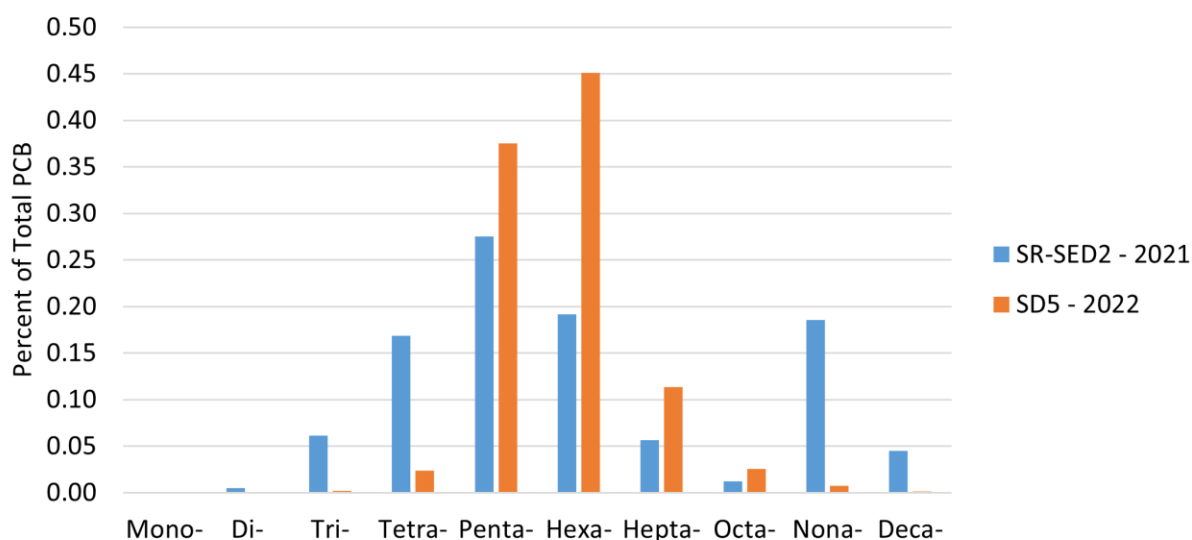
Figure 9. Homolog Comparison of Historic High Sediment Total PCB Samples.

Sediment sampling in the Mission Reach in 2021 identified a high total PCB concentration at SR-SED2 (300 ug/kg). The homolog distributions of the SR-SED2 sample and the SD5 sample are compared in Figure 9.

SR-SED2 had high nona- and deca-chloro homologs which indicated a potential contribution from Aroclor 1268. The homolog distribution at SD5 does not resemble that of SR-SED2 and is dominated by penta- and hexa-chloro homologs. The homolog distribution of SD5 most closely resembles Aroclor 1254 (cosine similarity of 0.82). Therefore, both the location and the potential contributing Aroclors appear to differ between 2021 and 2022.
