Spokane River Regional Toxics Task Force 2022 Measurement of PCBs in Biofilm and Sediment in the Spokane River

> Prepared for: Spokane River Regional Toxics Task Force

PRELIMINARY DRAFT June 21, 2023

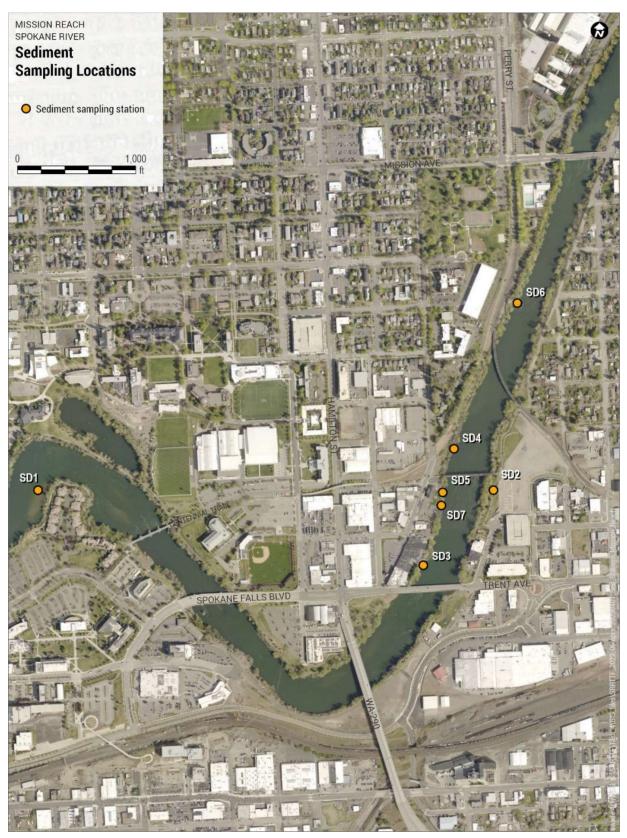
Figure 1. Map of 2022 Sediment Sampling Locations

Separate sampling locations were employed for sediments and biofilm. The locations for each are described below. Sediment sampling locations were selected to meet one of two criteria: 1) five locations immediately downstream of magnetic anomalies identified during the 2021 and 2022 object detection surveys and 2) two locations previously identified as having elevated sediment PCB concentrations during the 2018 Ecology monitoring or 2021 Task Force monitoring. The locations immediately downstream of magnetic anomalies were selected to indirectly determine whether the identified metallic objects are contributing measurable levels of PCBs to the river. The two locations associated with historically high sediment concentrations are designed to confirm the continued presence of elevated concentrations. The specific locations are described in Table 1 and shown in Figure 1.

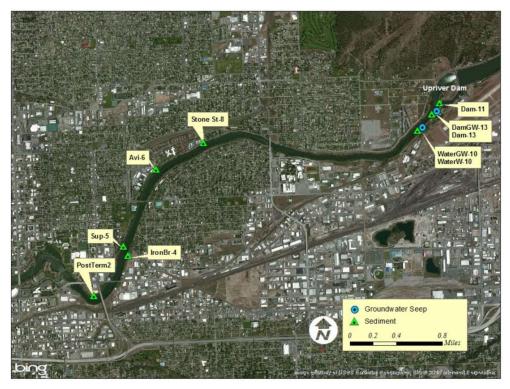
Figure 5. Ecology's Urban Waters Program 2013 Sediment Sampling Locations (from Era-Miller, 2015)

Ecology's Urban Waters Program sampled PCB content in Spokane River bottom sediments at eight locations in August 2013 (Figure 5). Seven of the stations were located upstream of Mission Reach with the eighth location (named PostTerm2) located within Mission Reach.

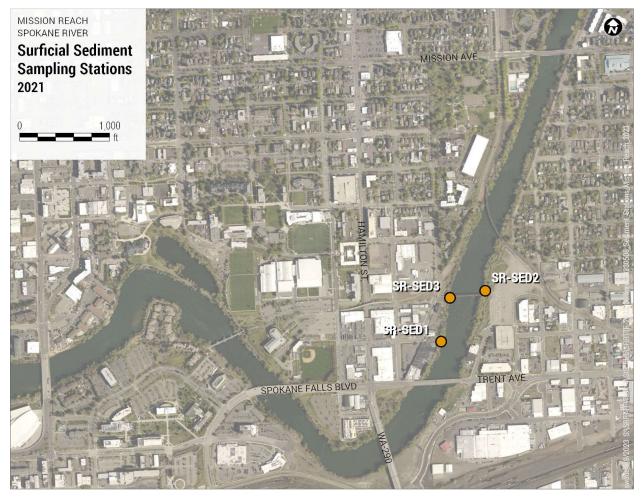
Figure 7. Mission Reach Sediment Stations Monitored in 2021

The Task Force also conducted limited sediment monitoring in the Mission Reach in 2021 (LimnoTech, 2022c) with three stations sampled as shown in Figure 7.
