Spokane Reach PCB Canine Surveys 2021

Julianne Ubigau & Jasper
FieldLab Detection Services
September 2021

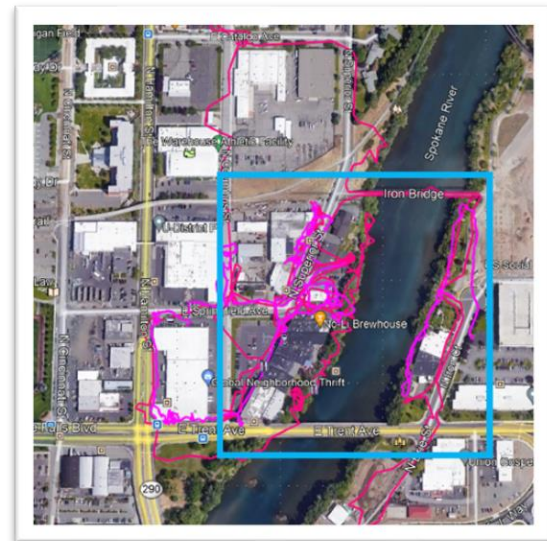
Figure 2. Study Area and Tracklog Coverage

Canine surveys took place on August 29-31st 2021. The survey area was prioritized to the area between North Columbia Street (western perimeter) and Iron Bridge Court (eastern perimeter), the Iron Bridge (northern perimeter) and Trent Avenue (southern perimeter). The canine team was granted access to search the Riverwalk building on the right bank and properties owned by MGD LLC. (Figure 1). Canine and handler surveyed the priority area by searching both sides of the riverbank and by walking the perimeter of buildings and property lines within designated areas. Due to canine interest, surveys were extended westward to East Hamilton Street and north to East Cataldo Avenue Survey. Coverage was recorded using GPS track logger (Figure 2).

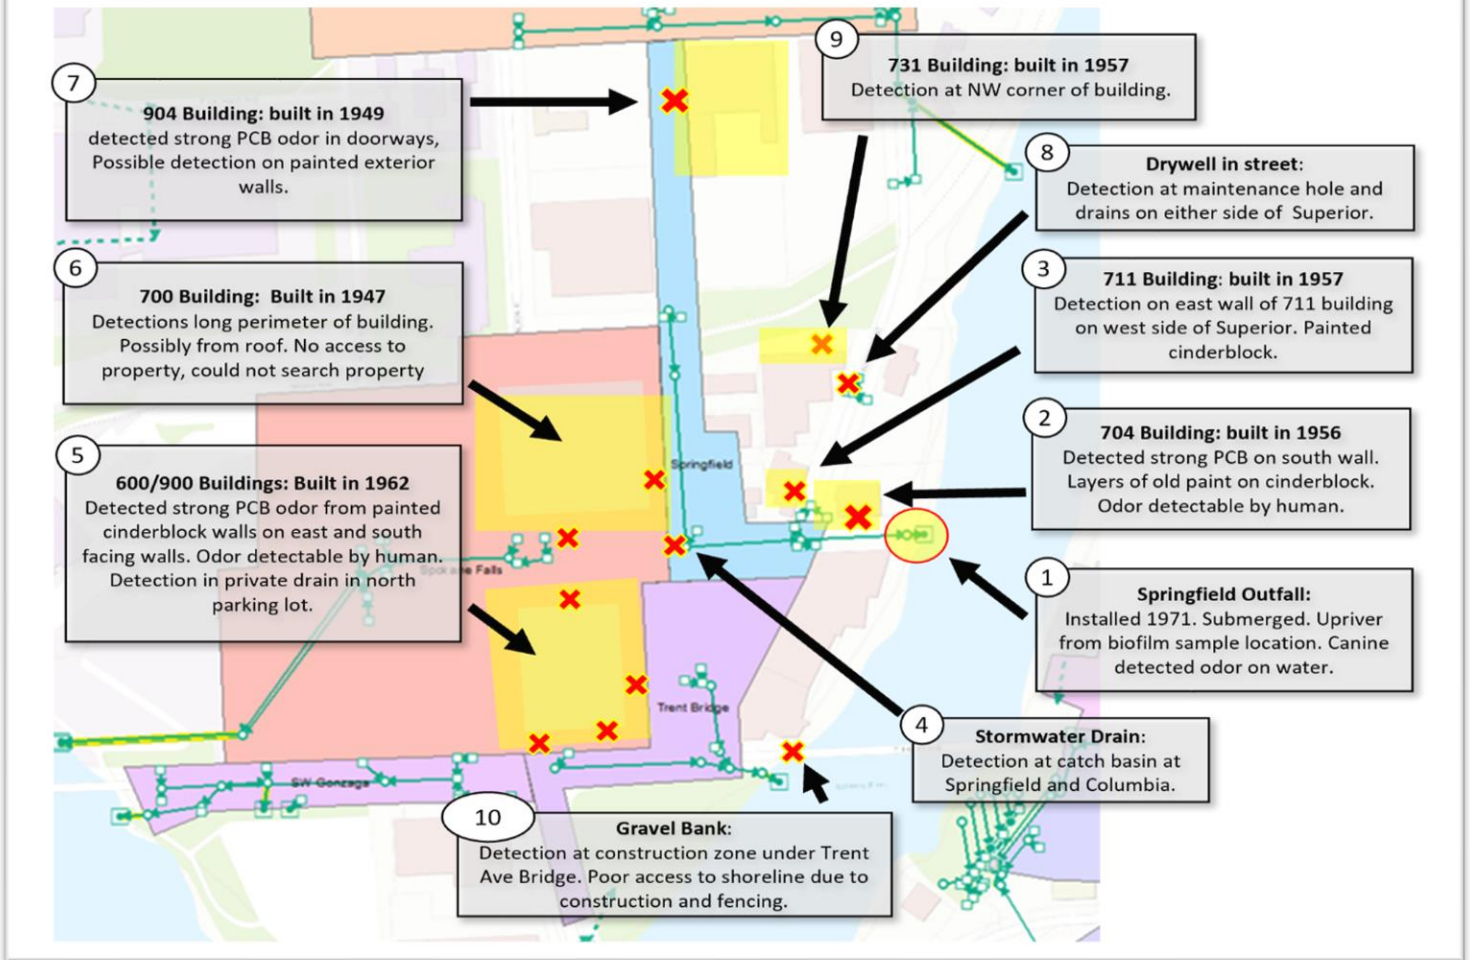
Figure 7. Top ten detection sites

There were 10 areas of high interest to the detection dog. The map above shows a summary of these 10 sites and the underlying stormwater system that drains directly into the Spokane River (Figure 7). Data for outfalls and stormwater lines can be found online at www.my.spokanecity.org and in the [PCB Canine Project](#) folder.

Sites are numbered 1-10 based on probable relevance to the SR3A-RB PCB hotspot. The following section provides a more detailed description for each site.

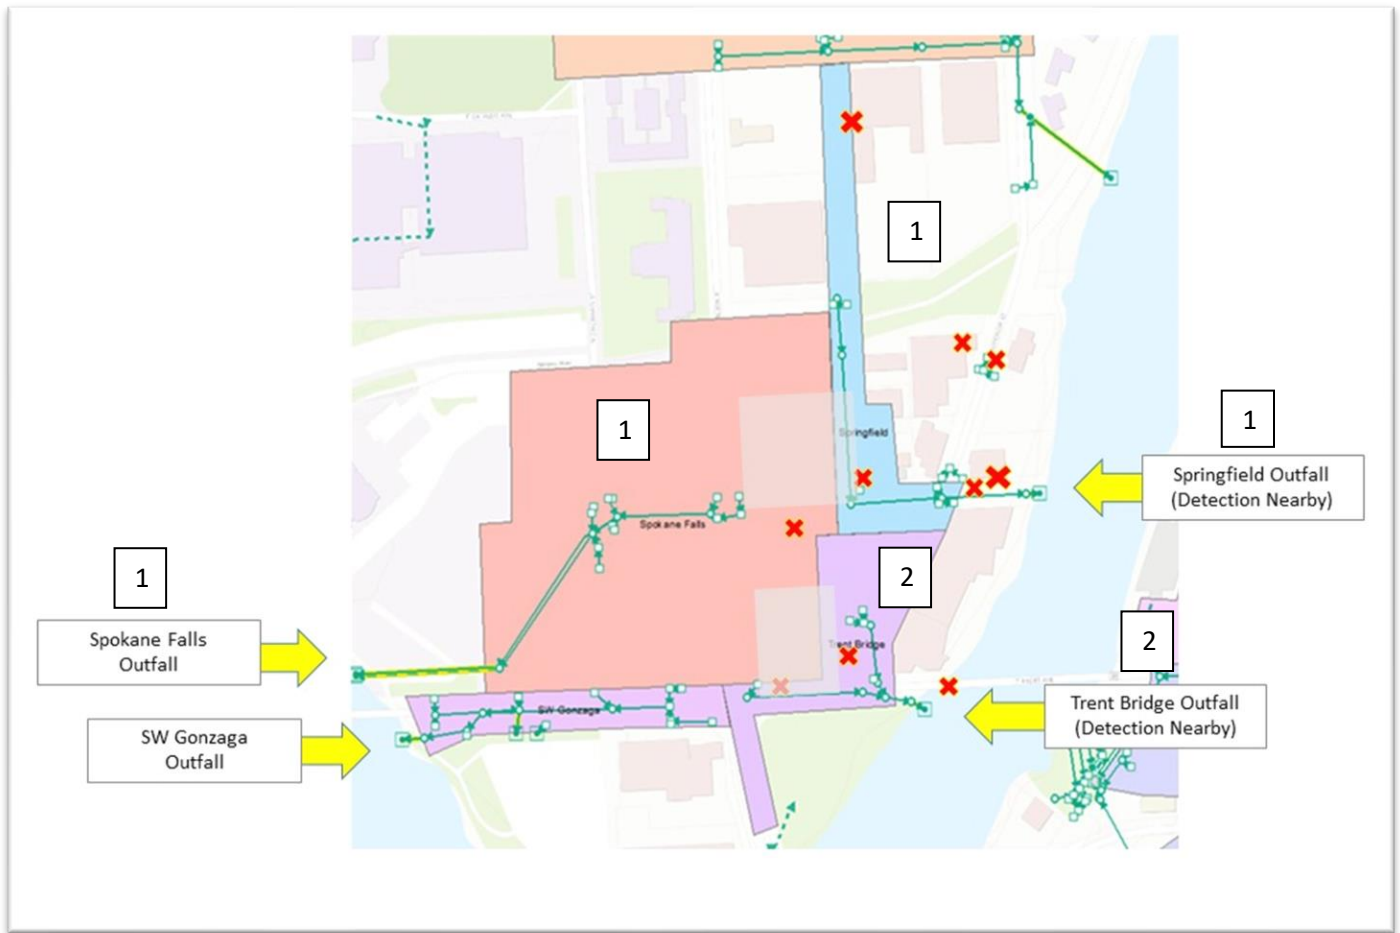
Figure 20. Springfield, Trent Bridge and Spokane Falls basin and outfalls.

Based on the PCB detections made in this area, the canine detection team has concluded that the source of PCBs is likely from buildings and contaminated soil within the Springfield stormwater basin which discharges to an outfall near the SR3A-RB PCB hotspot. The number of buildings positive for PCB in the survey zone suggests that there may be higher levels of PCBs in three stormwater basins that serve this area: Springfield, Trent Bridge and Spokane Falls. Testing the level of PCBs in biofilm at each outfall and testing catch basins in these mainlines could help determine if the PCB hotspot is caused by building materials and historic operations that took place here, or if the source is underground and not detectable by a detection dog.
